## Tree Condition Assessment Prepared for

Harberton Parish Council Parks and Green Space

Date: 11<sup>th</sup> September 2021

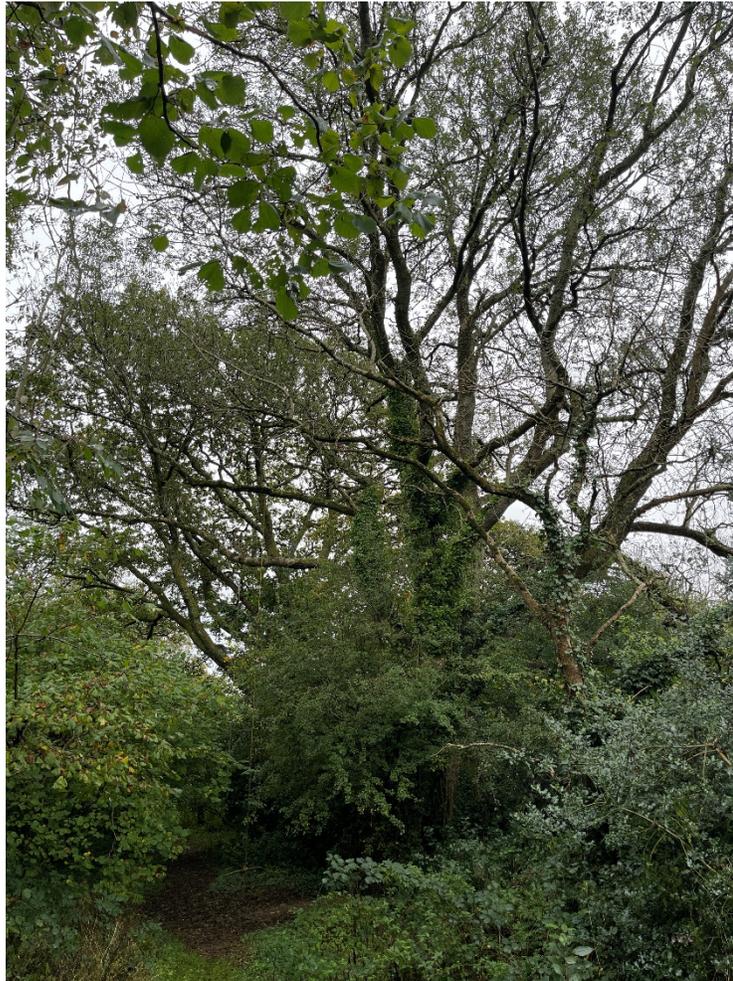
- 4.1.2 Since the previous survey the ash trees at the playing fields are showing no signs of being in a worse condition than when viewed in 2020. The ash trees close to the play park and main entrance to the car park are still in leaf with only minor/ moderate crown dieback at present, therefore, these trees should be continued to be monitored in the summer months.

Photograph 2: Large mature ash with rope swing still in leaf in October.

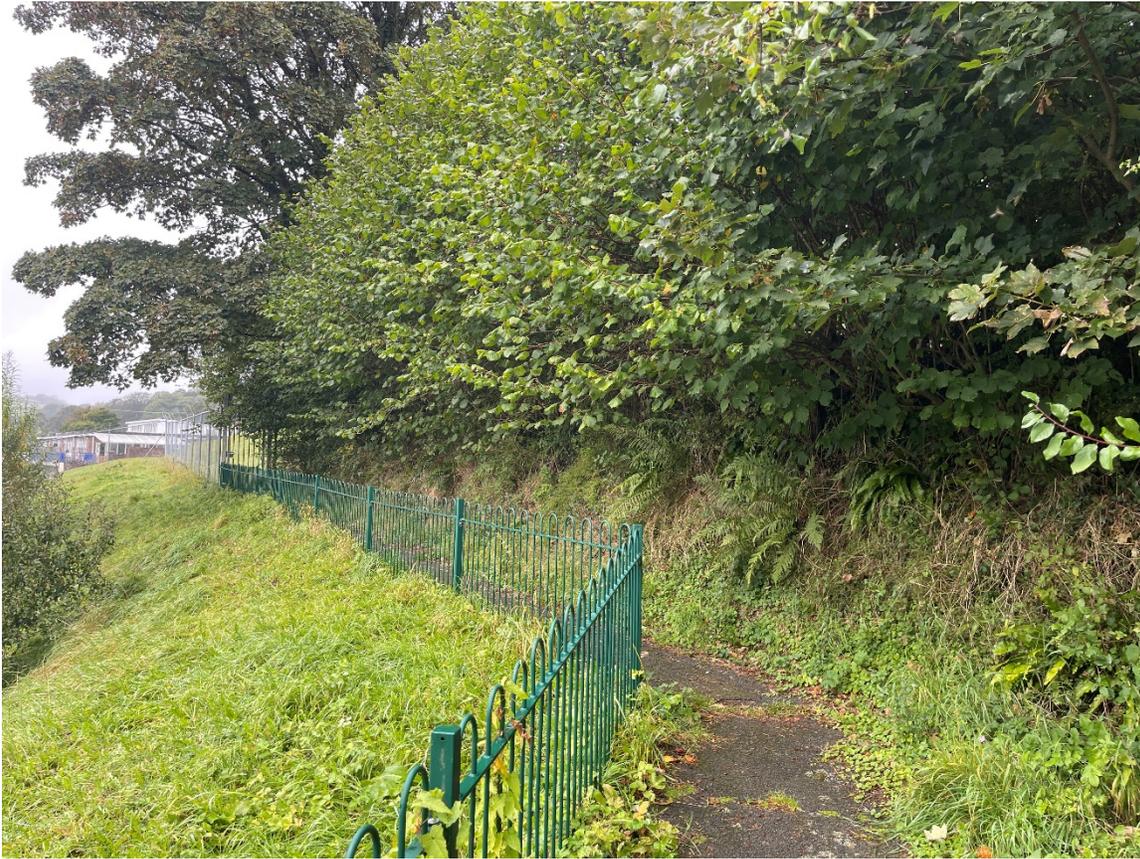
- 4.2.2 Compartment 1 consists of planted specimen trees and a willow arbor growing close to the playpark apparatus. I did not observe any significant defects at the time of inspection. The hedge growing adjacent to the footpath from the school to the park is overgrown with low hanging branches over the footpath. I recommend the branches be cut back in order to attain a height clearance of approximately 2-3 metres and reduced off the footpath.

Photograph 3: Hazel hedgerow growing into footpath to school.

Tree No.	Species	Observations	Recommendations	Work Priority
C1	Mixed Broadleaf	<ul style="list-style-type: none"> <li>Ornamental and self-seeded specimen trees around play park equipment.</li> <li>Hazel hedge overhanging footpath.</li> </ul>	<ul style="list-style-type: none"> <li>Cut back foliage and branches overhanging footpath from school to play park. Crown raise to give 2-3 metres clearance overhanging footpath.</li> </ul>	<b>Low – Works to be carried out within 12 months</b>
