Tree Condition Assessment Prepared for

Harberton Parish Council Parks and Green Space

Date: 15th June 2023

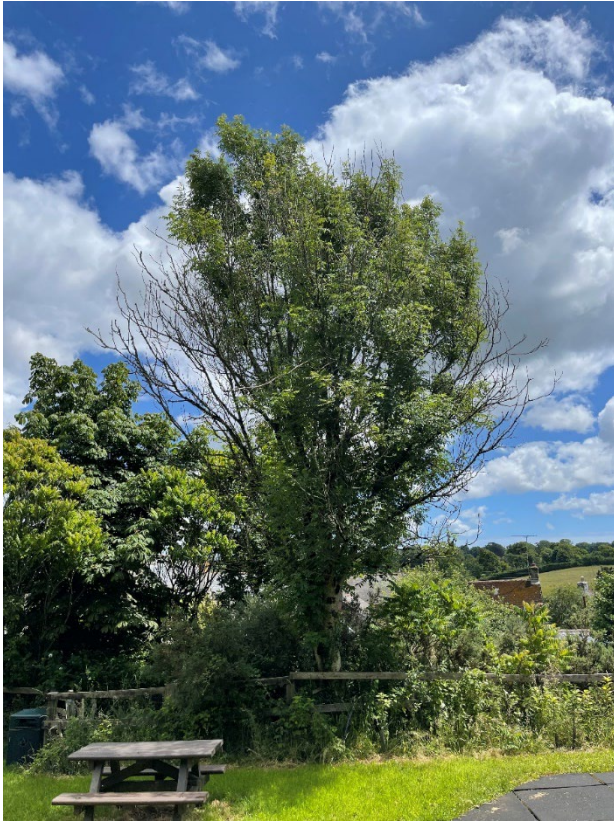
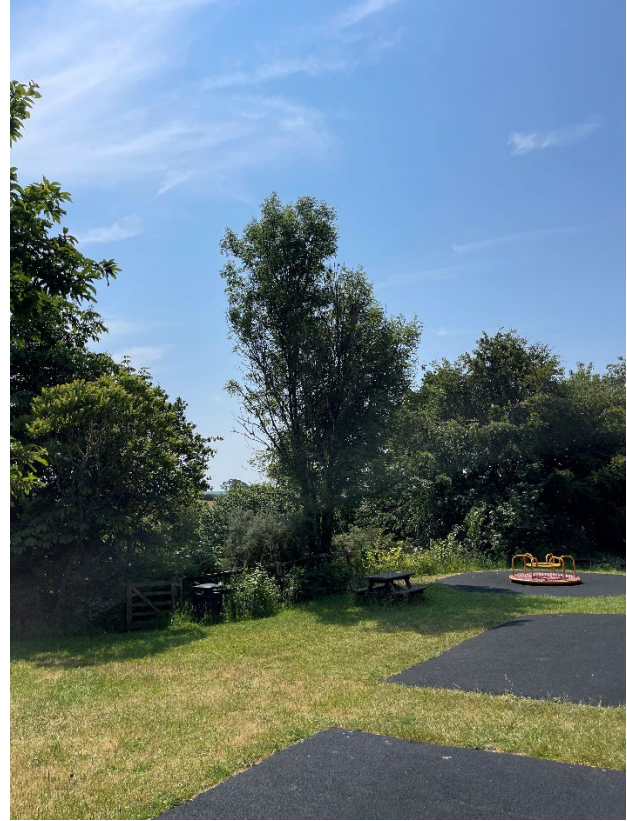
field from the children's playpark which appeared to have only very minor signs of ADB in the crowns of the trees. The ash trees appear to be unchanged and are considered to be a low risk at present.

Photograph 1 and 2: Ash tree with ADB in the park in 2022 (left) and 2023 (right).

- 4.1.3 Since the previous survey the ash trees at the playing fields are showing no signs of being in a worse condition than when viewed in 2022 and appeared to have improved for some. The ash tree close to the main entrance to the car park has been felled, although I do not believe that this tree was a risk and had all the signs of recovery and good vitality lower in the crown of the tree.

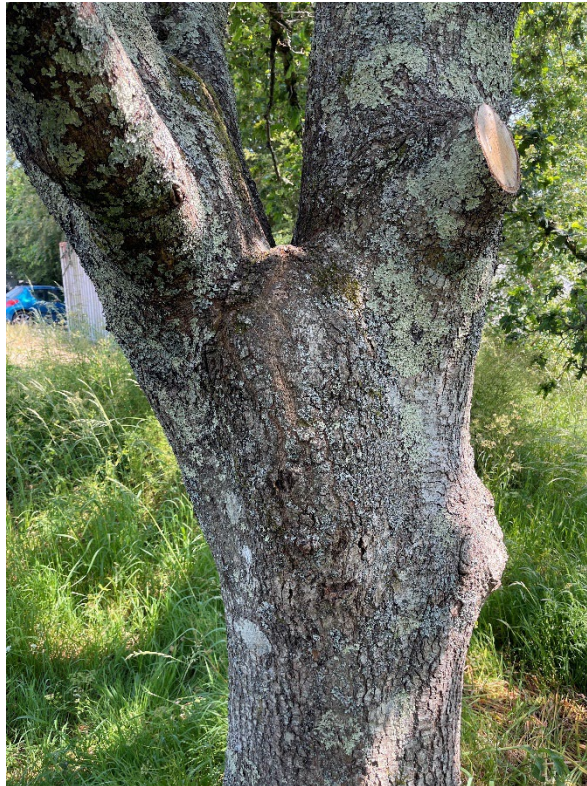
- 4.1.4 Within the central belt of trees is a singular oak tree with a swing attached to the lower branches. The tree has an open grown crown with a good shape and is approximately 15 metres in height. The main trunk bifurcates at approximately 1.5 metres with an included union which appears to be stable at present. Included unions or bark inclusions can form where stems or branches growing in close contact to one another can form inherently weak unions to a main trunk or subsidiary stems. This is where the union of the two stems or branches do not unite with one another and the presence of the stem bark ridge rolls inward and creates bark to bark contact. As the two members grow, load stress (usually from wind and weight) creates pressure between the two stems and the tree produces adaptive growth to compensate for the weak union. This can be observed as an increased

formation of wood on either side of the union and is commonly known as a compression fork. The increasing stimulus of growth around the union, the presence of 'pursed lips', cracking and / or watermarking on the main trunk can indicate that a stem or branch is poorly attached and could be represent a high risk of failure. At present the union appears to be stable but should be regularly monitored for any change in condition.

Photograph 3: Oak in park with stable included union to monitor.

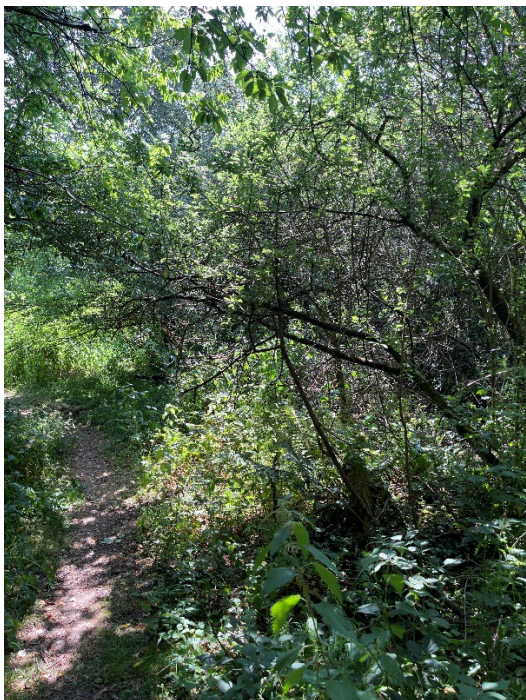
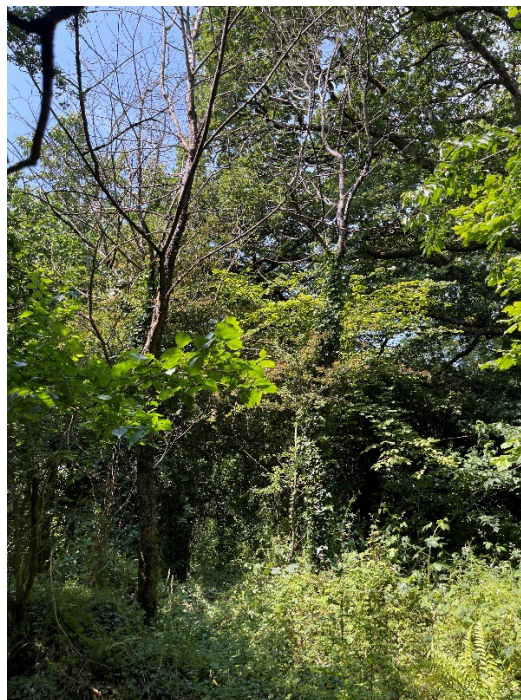
- 4.2.1 Compartment 2 comprises of a banked wooded area of young ash, cherry and hazel trees growing next to the original field boundary to the south-west. Along the original hedgerow and within the wooded area there is a large mature oak and ash tree. A number of the younger ash within the wooded group appear to be in an improved condition than when they were viewed in 2022 and are considered to be a low risk due to the target area.
- 4.2.2 Within the wooded area there are three dead elms trees and a partially fallen blackthorn close to the footpath along the south-western boundary. These trees are small and are currently a low risk (Broadly Acceptable). I have recommended to remove the trees if funds allow.

Photographs 4 and 5: Blackthorn (left) close to footpath and three dead elm trees (right).

C2	Mixed Broadleaf	M-EM	Up to 20	Up to 1050	G	<ul style="list-style-type: none">Trees growing on boundary bank and wooded planted area.Planted young specimens of cherry, hazel and ash.Large mature boundary oak and two ash. Ash trees are in good physiological condition.Group of 3 x dead elms and fallen blackthorn to fell next to footpath.	<ul style="list-style-type: none">Fell 3 x dead elms and fallen blackthorn stem along woodland footpath.	3	1	5	<1M	1

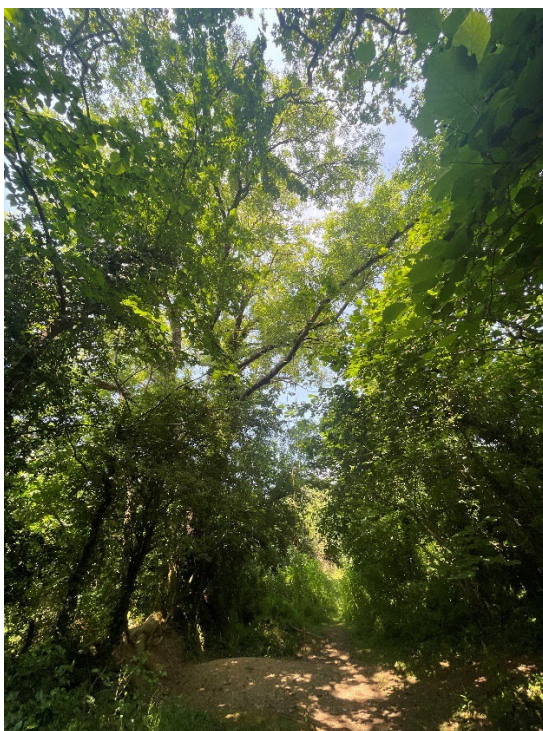
Photograph 6: Large mature ash in good condition in Compartment 2.

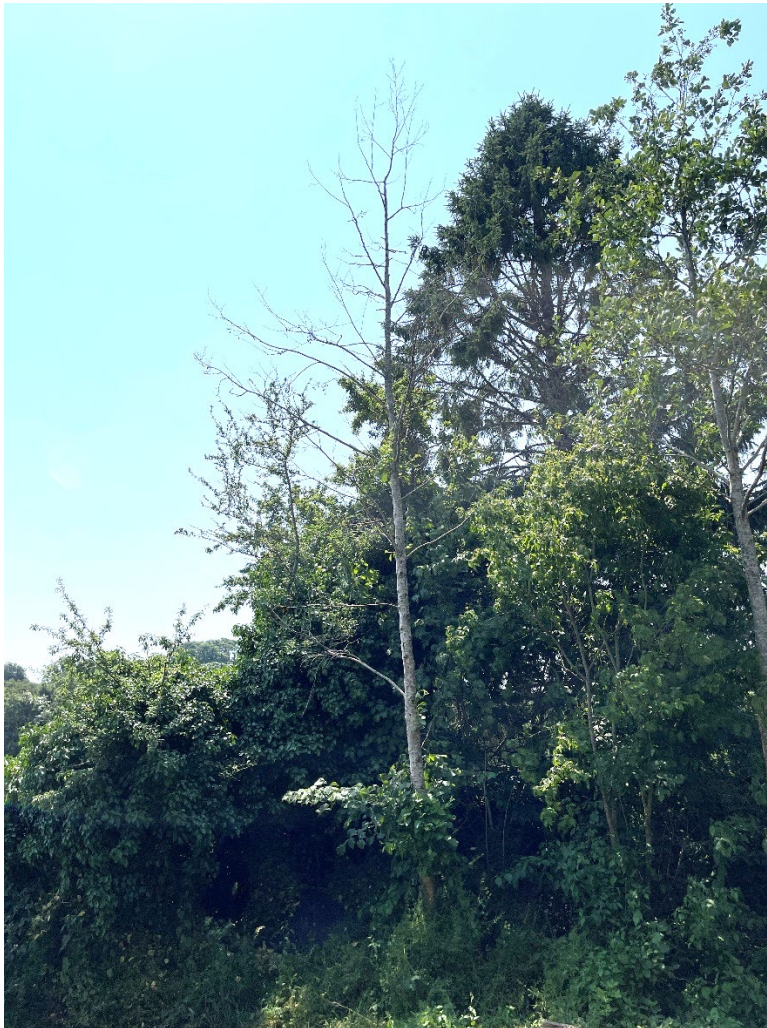
- 4.4.1 Harbertonford Playpark is a small park located in the village of Harbertonford near Totnes, Devon. The Park is located and accessed from Riverdale and the park can also be accessed from the grounds of Harbertonford Church of England Primary School. The playpark has climbing apparatus and a small football pitch with a number of small planted specimens, a willow arbor and groups of historic coppice boundary ash and sycamore trees.
- 4.4.2 Compartment 1 consists of planted specimen trees and a willow arbor growing close to the playpark apparatus. I did not observe any significant defects at the time of inspection. The hedge growing adjacent to the footpath from the school to the park is overgrown with low hanging branches over the footpath. There is a very small dead alder tree next to the main entrance of the park which would be best felled.

Photograph 7: Dead alder tree next to the main entrance of the park.

Harberton Playpark	C1	Mixed Broadleaf	<ul style="list-style-type: none"> Ornamental and self-seeded specimen trees around play park equipment. Small dead alder tree by entrance 	<ul style="list-style-type: none"> Fell small dead alder tree next to entrance. 	Low – Works to be carried out within 12 months
