Harberton Flood

17th September 2023

1 Purpose and scope

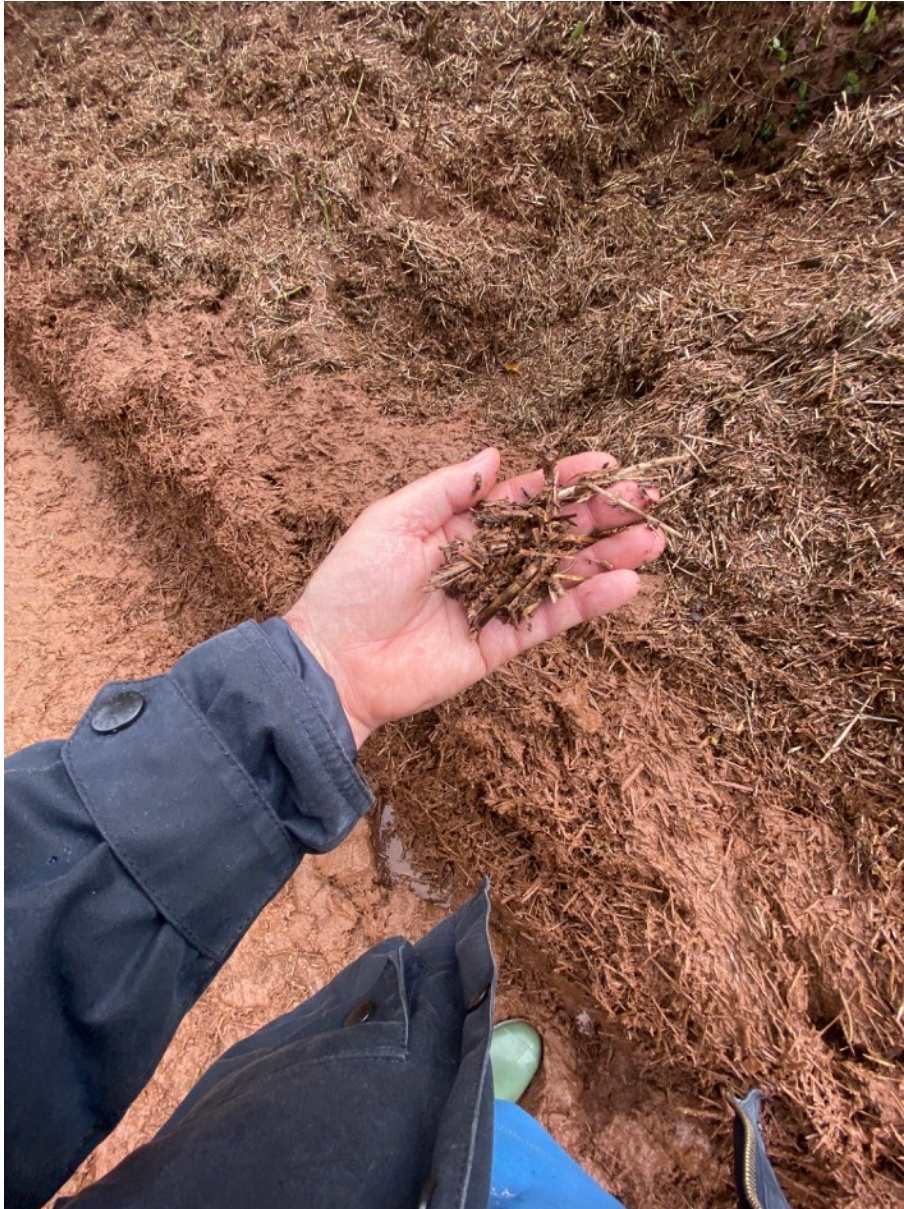
The flood stream consisted of water-borne mud and chopped straw.

The fields north of Screw Lane had been minimally tilled in line with current farming practice. This resulted in short lengths of straw on a shallow bed of tilled dry soil, with a compacted soil sub-base.

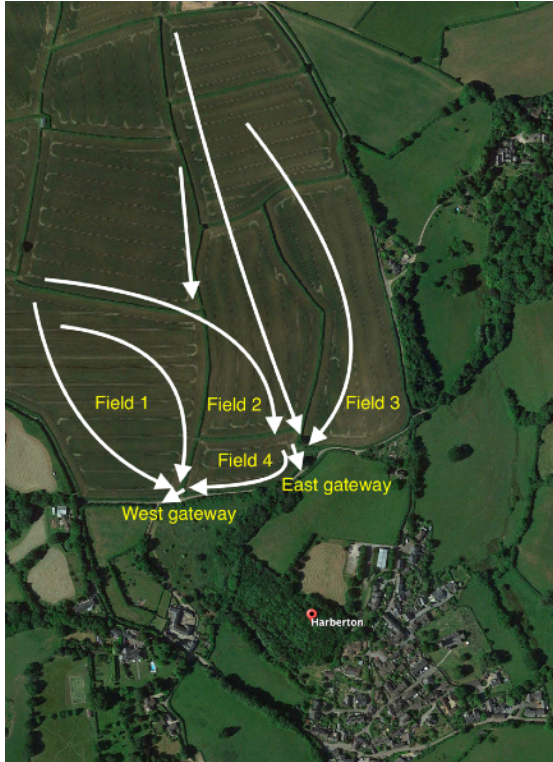
5.2.1 The water ran down the fields north of Screw Lane. Fields 1,2,3 and 4 were freshly tilled, the others to the north had a well-established crop.

The water, mud and straw gathered against the southern borders of those fields forming the north border of Screw Lane.

The white lines show the flow paths as seen in the photographs. Detailed photos are available.

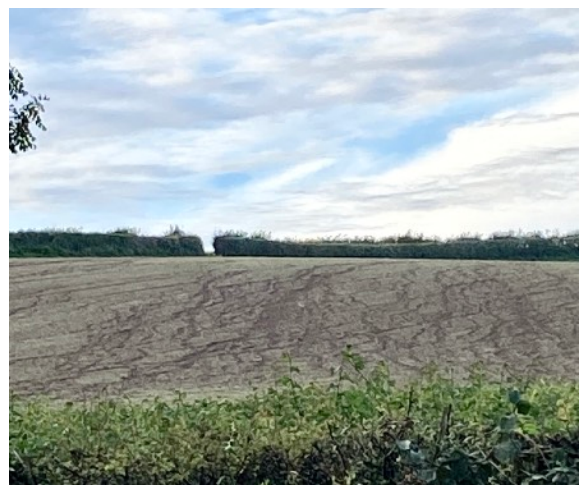
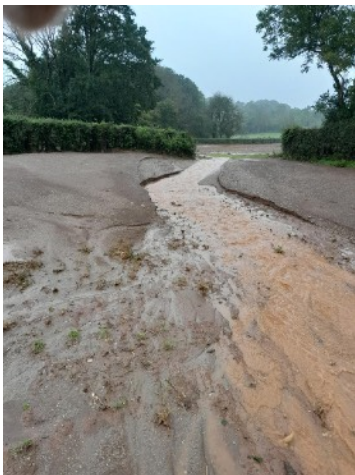
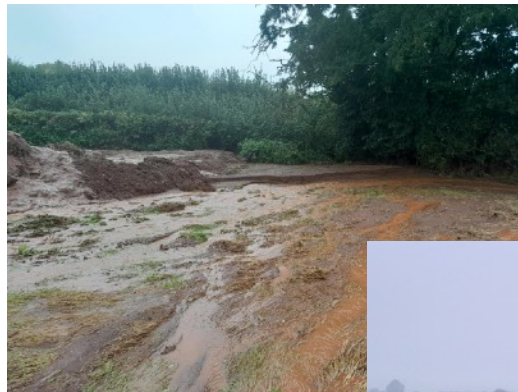
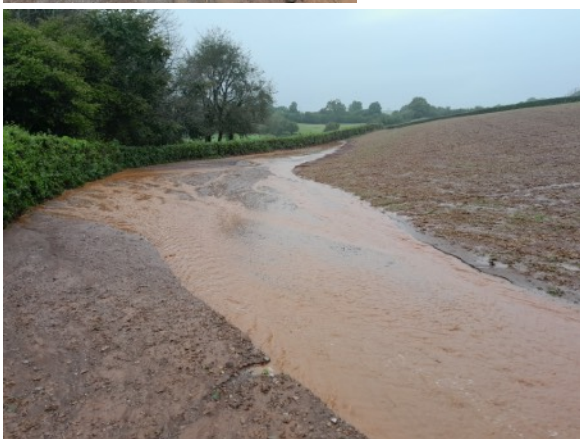
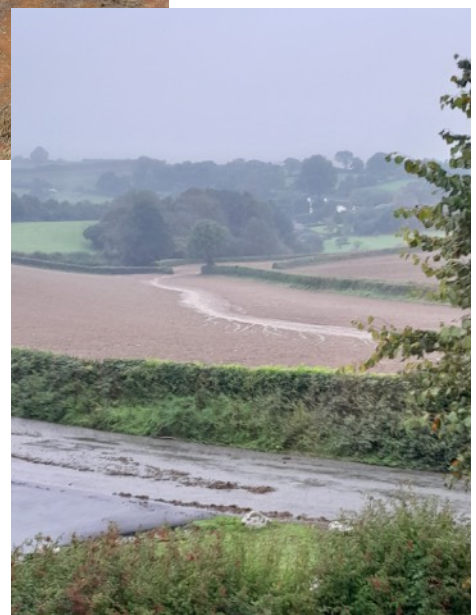
The water exited onto Screw Lane at various points, but particularly through the two gateways at east and west parts of the lane.

Water banked up and pooled along the fields' southern banking forming the north side of Screw Lane.

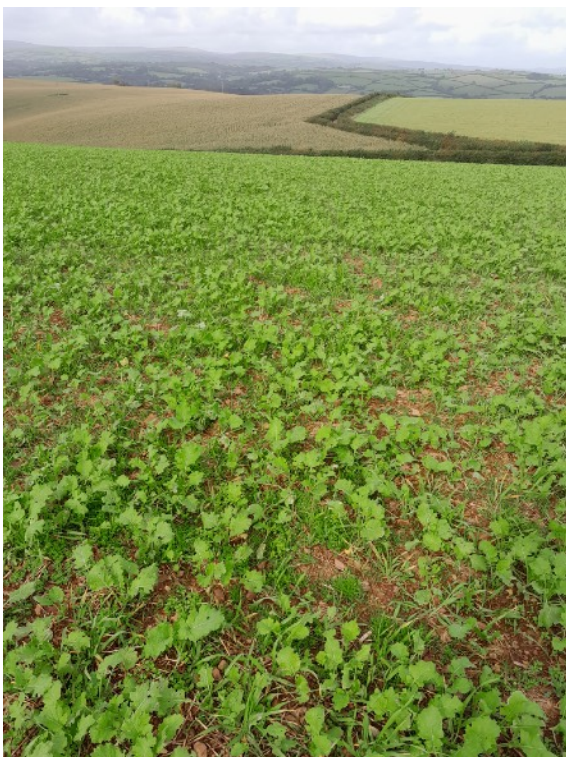
Established crop north of fields 1,2,3 and 4, looking down on the freshly-tilled and seeded fields in the far distance.

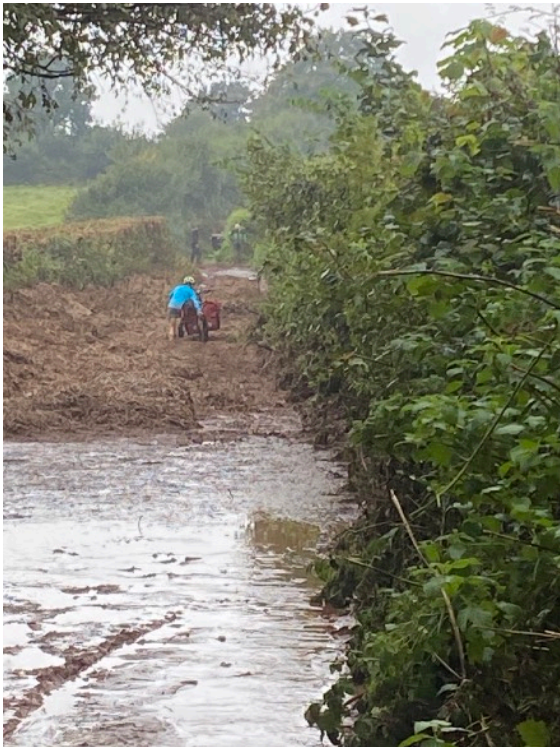
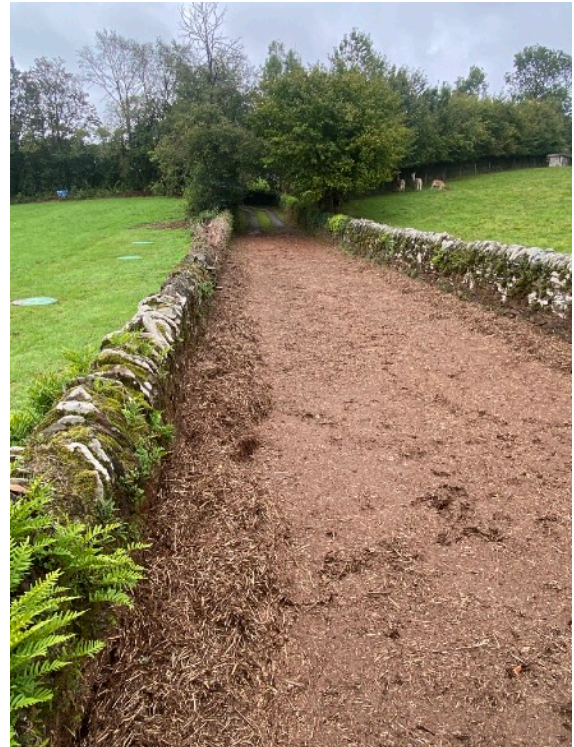
5.2.3 Screw Lane has a slight hump to the east of Field 1's gate. This caused the flow from this field to head west which spilled round and pooled in Threshing Barn's driveway.

Threshing Barn's driveway walls held. As Screw Lane filled up, the hump was submerged, and the gateway and buddle holes on the south side of Screw Lane overflowed. Screw Lane became a huge attenuation pool.

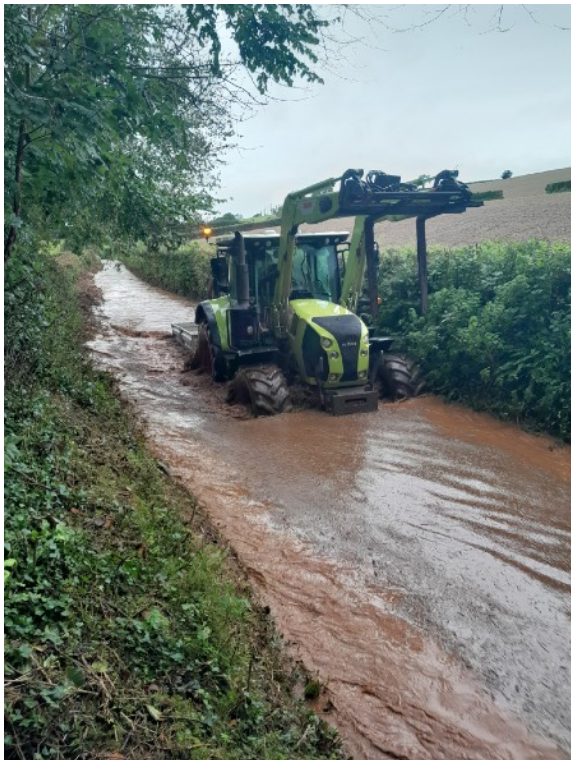
A tractor the following morning in the lower part of Screw Lane, heading east.

Note the left hand stream still running towards the tractor.

Screw Lane's hump is still submerged, 10 m behind the tractor.

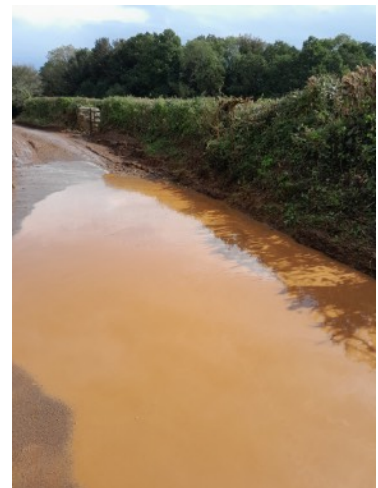
Here is the hump some time later ...

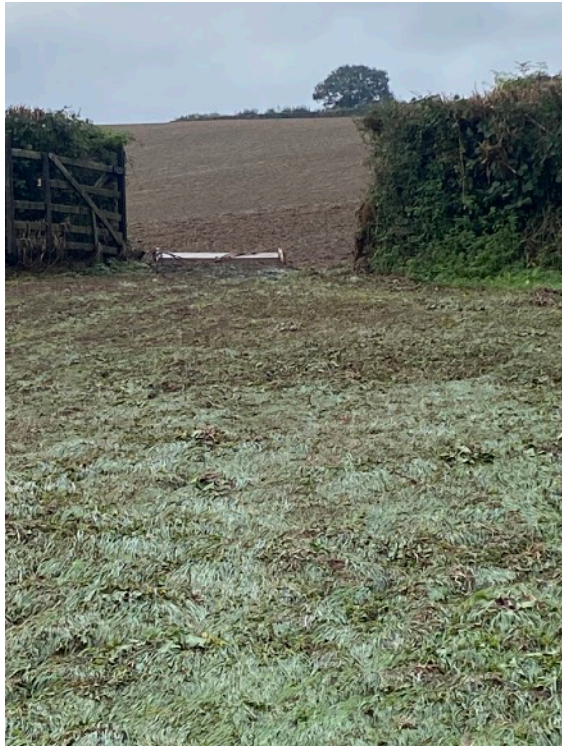
Main flow from upper field, across Screw Lane

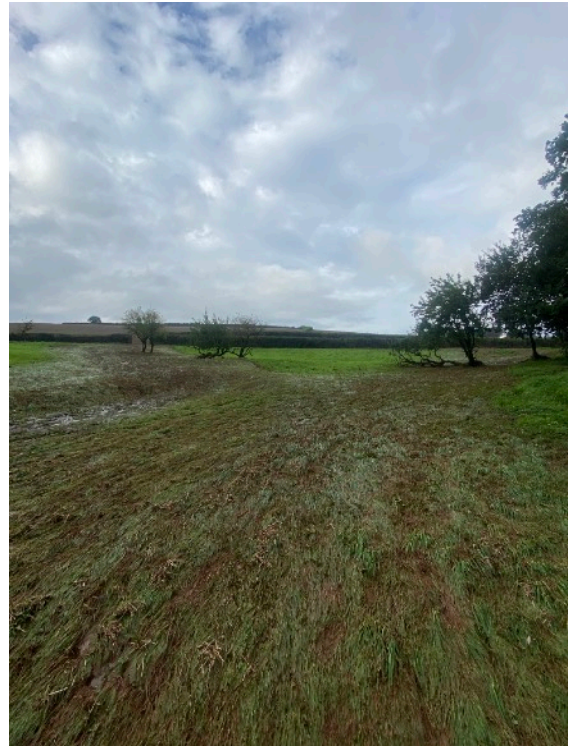
Looking north at 2 streams heading south forming a 'Y' shape

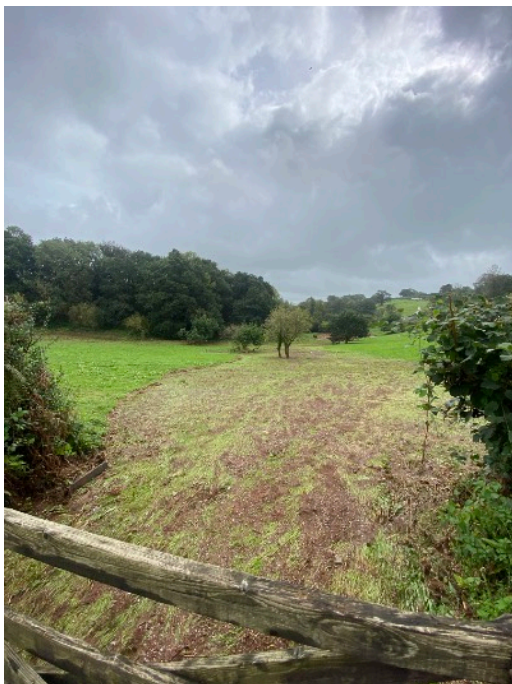
One stream heading south

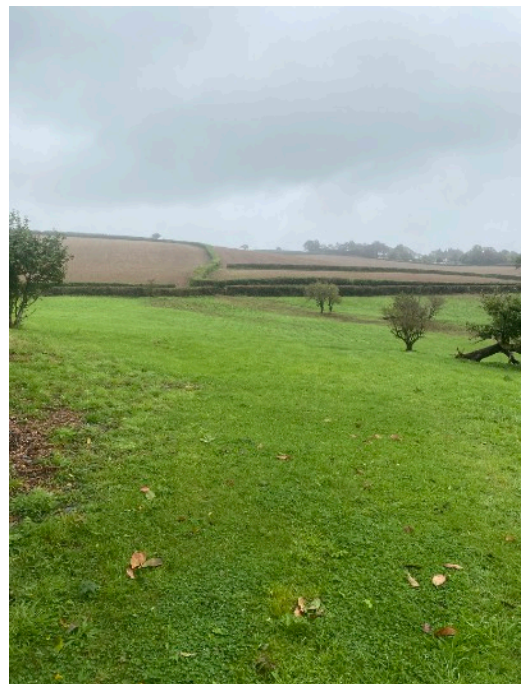
Stream with fields in upper background

This grassland had only recently been cleared of brambles and other vegetation

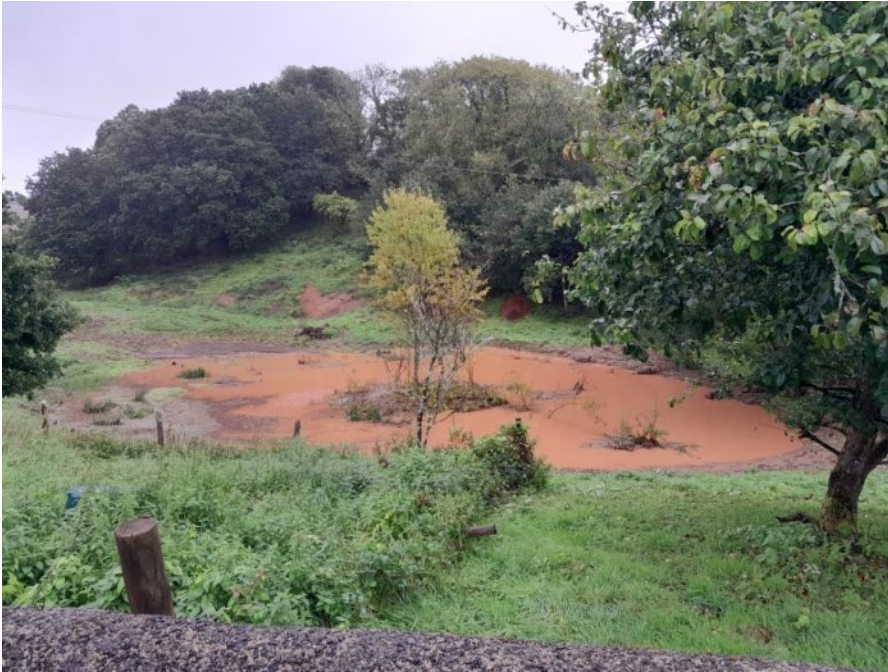
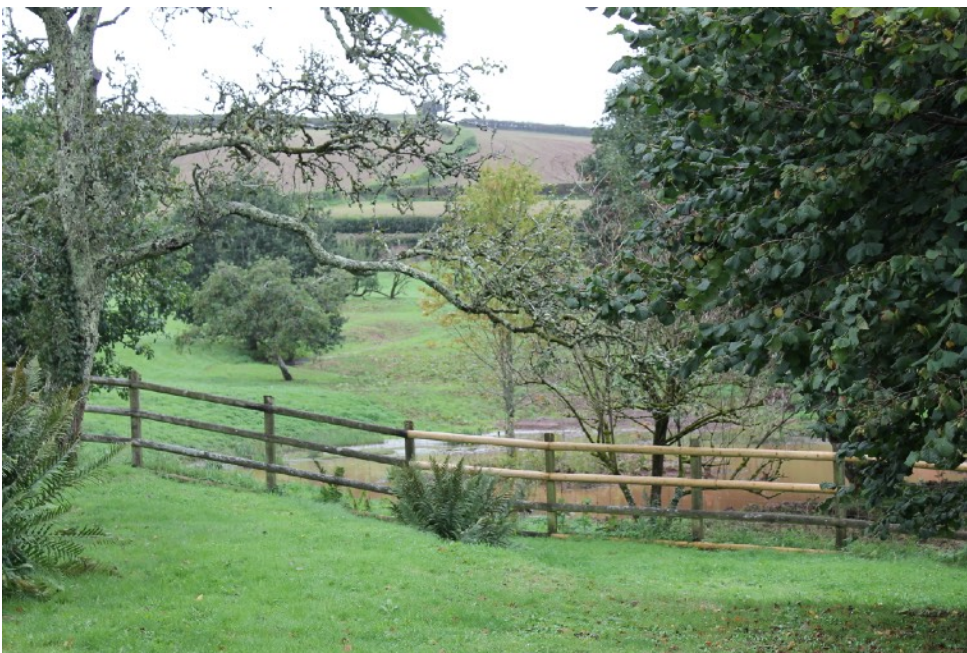
5.2.5 The two streams ran south down across the grassland bowl into an existing pond.

This pond was dug many years ago to act as an attenuation pool for flood water. There were plans to deepen it as it had silted up over recent years. Many years ago hurdles were placed above this pond to capture silt from above. Being shallow, the pond overflowed, but it's banks remained intact and were not scoured.

Looking north towards field 1 in the upper part of this shot, with the pond in the foreground

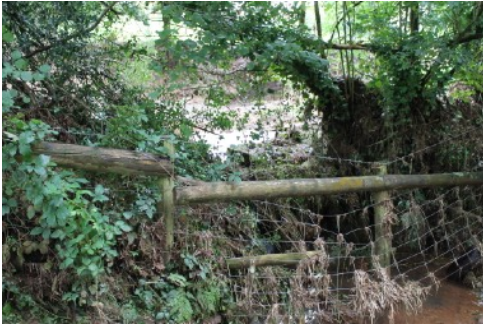
5.2.6 The pond overflowed into this subordinate pool,

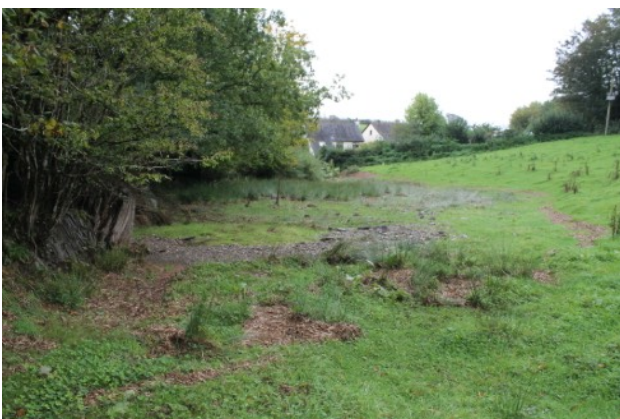
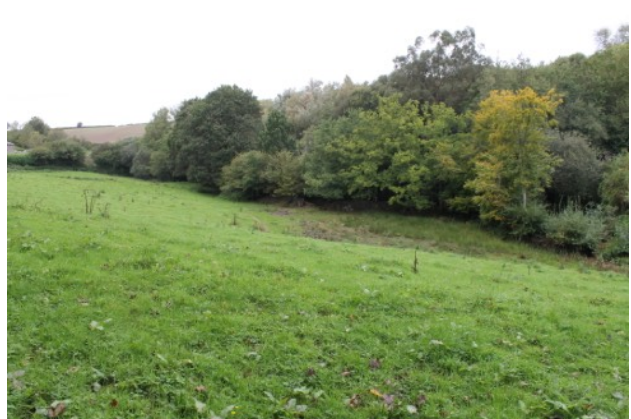
The stream has 1.5m levees on it's west bank to protect the field to the south. However there are gaps in the levee which caused spillage

Levee gap and spillage

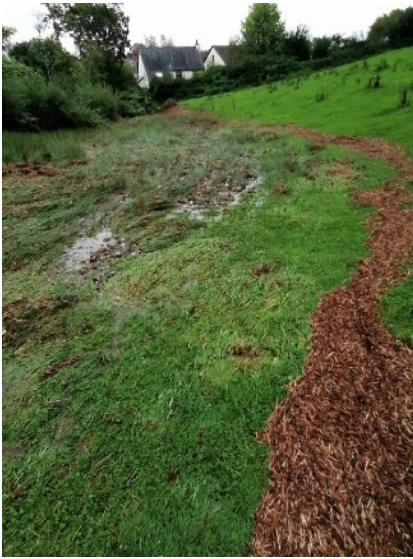
The levee spillage eastwards was significant. It backed up against the Gunnera plants behind Ashbrook Cottage

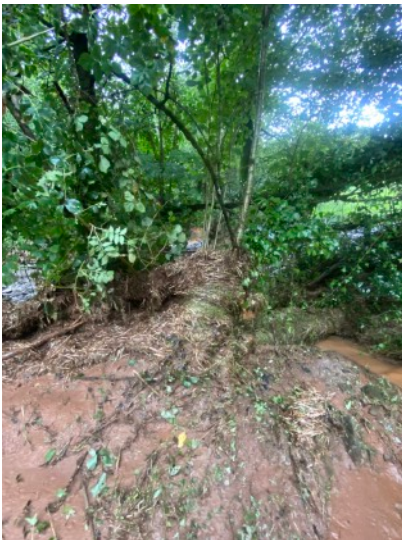
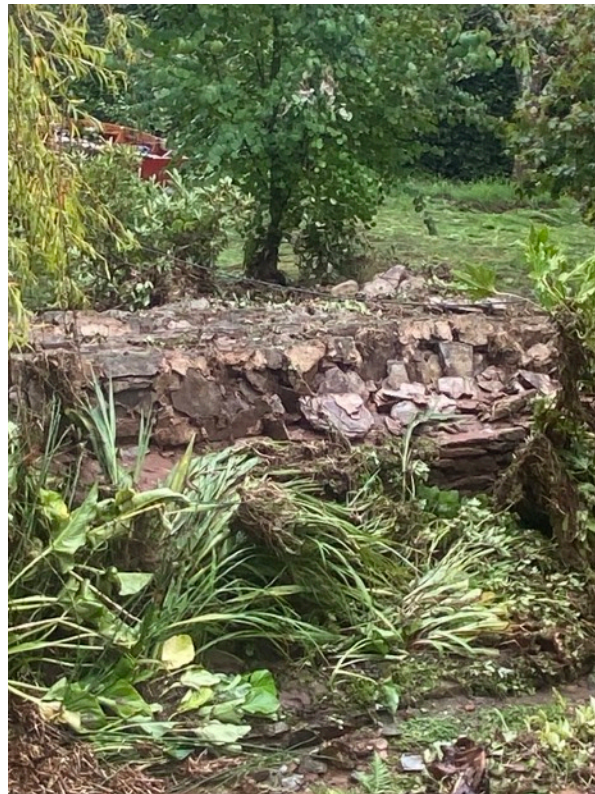
5.2.7 The stream pushed through to the side of Ashbrook Cottage where it pushed over a north wall. It spilled north to Town Farm and east along the road behind St Clement's Terrace.

Collapsed wall at Ashbrook Cottage

9.2.1 All stream-facing walls should be inspected for integrity and made flood-load bearing. Flood walls and gates must not be too high. Over-topping must be possible to reduce static and dynamic water pressure.

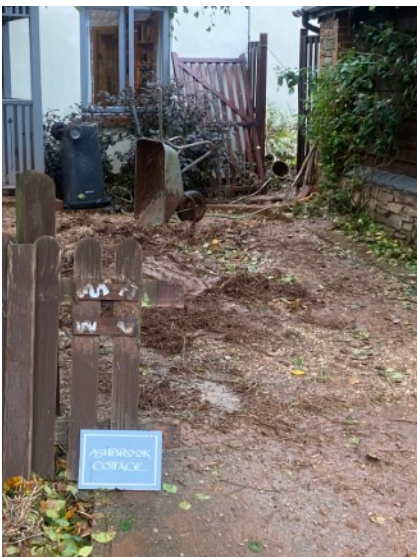
South east flow through Ashbrook Cottage side gateway.

The front garden's picket fence was carried across the car-park to St Clement's terrace.

9.1.2 Ashbrook Cottage, The Old Forge, Preston Barns and the St Clement's Terrace front gardens should have spillways to take the flow to the stream.

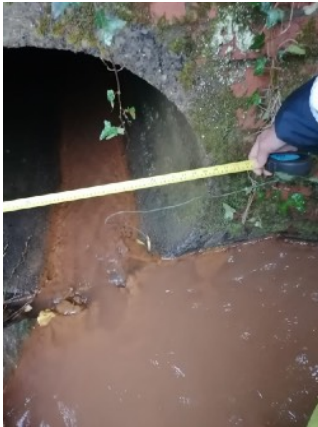
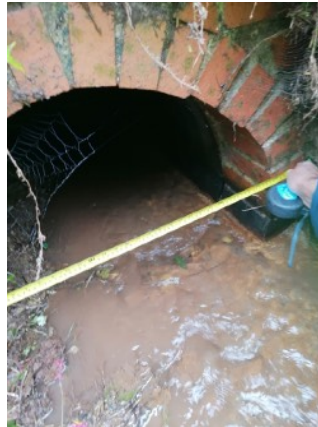
Culverts 1 and 2

The first culvert heads west under Ashbrook Cottage's garage. This culvert was overwhelmed. The flow went around both sides of the garage, taking the side gate off it's hinges.

The flow through the Ashbrook culvert then went west for a few metres to Town Farm Barn. It dog-legs at Town Farm Barn's rear culvert. Town Farm Barn flooded from front and rear as the flow went approx 220 degrees around the house.

Ashbrook Cottage and Town Farm Barn both 740 mm diameter, 0.43 m²

It is not good practice to have the last in the series half the size of the two upstream. They were installed at different times.

9.1.6 Culvert CSAs and use of debris gratings needs to be validated.

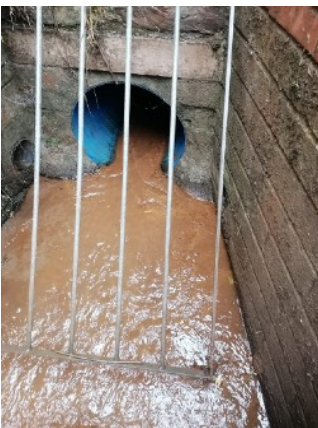
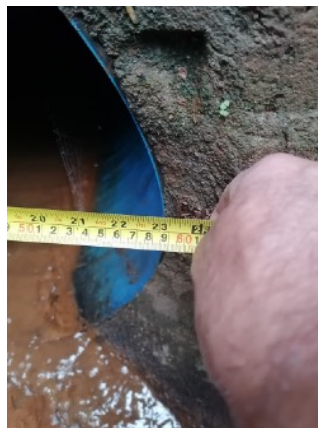
Culvert 3

St Clement's culvert 590 mm, 0.27 m²

Only St Clement's has an inclined debris grating, which became clogged.

In particular, can St Clement's 0.27 m² culvert pass 4,500 m³ in 15 minutes?

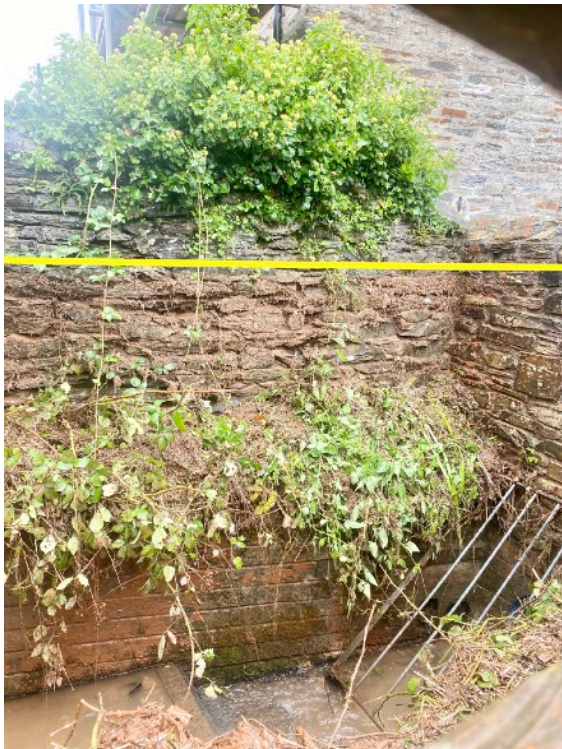
5.2.9 The main stream then ran downhill to the south. It blocked the culvert at the western end of St Clement's Terrace. Fortunately, the north wall behind St Clement's was not breached.

Note the water mark in the culvert is 250mm (10 inches) below the topping stones.

Inclined grating over the culvert

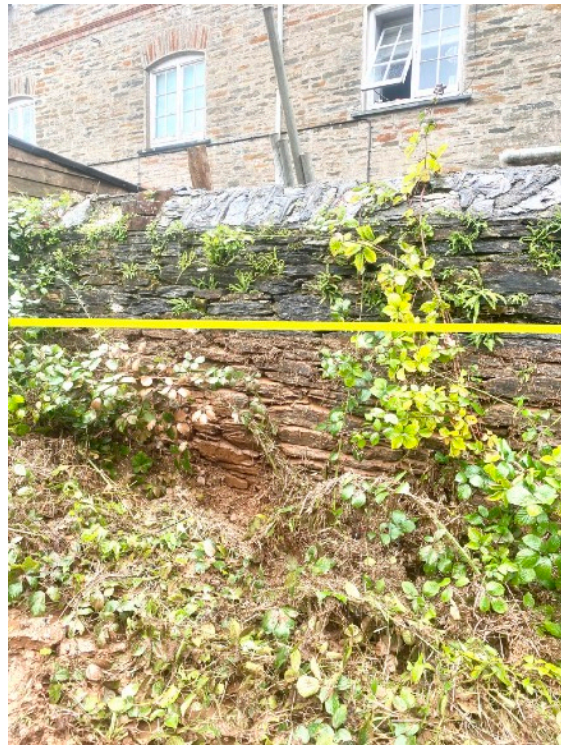
St Clement's rear wall

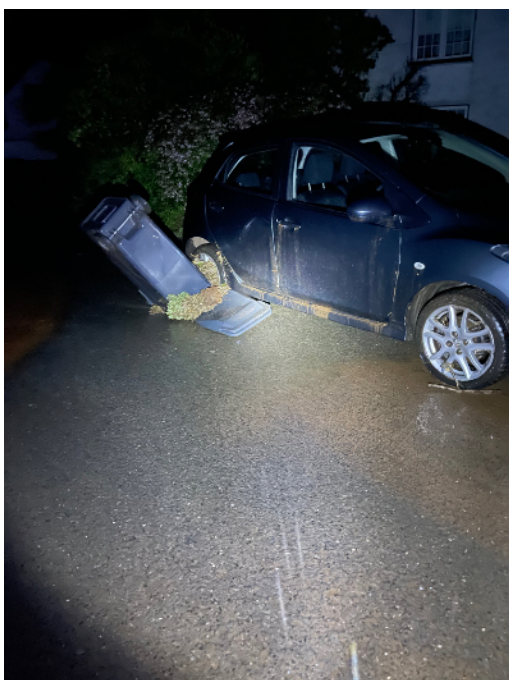
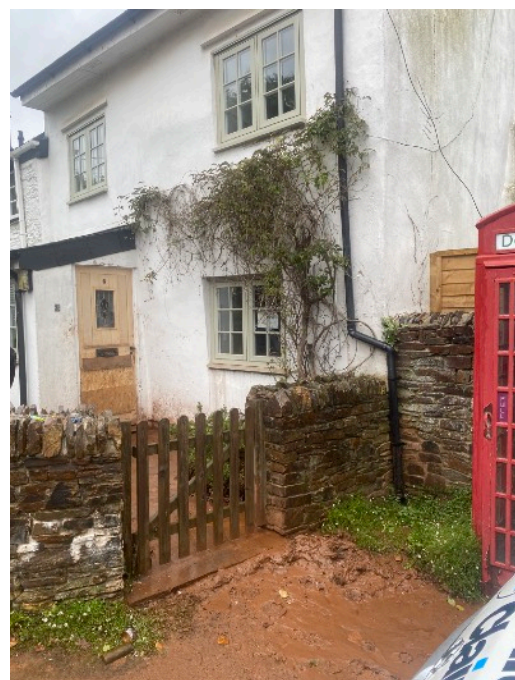
The flow spread out to all low-lying properties to the south, including 6 Wesley Place where it entered the rear, traversed the house, and exited the front door at letterbox level. It also went east to Tristford Road where colliding floating wheelie bins woke the first responder.

The flow flooded the front gardens of St Clement's

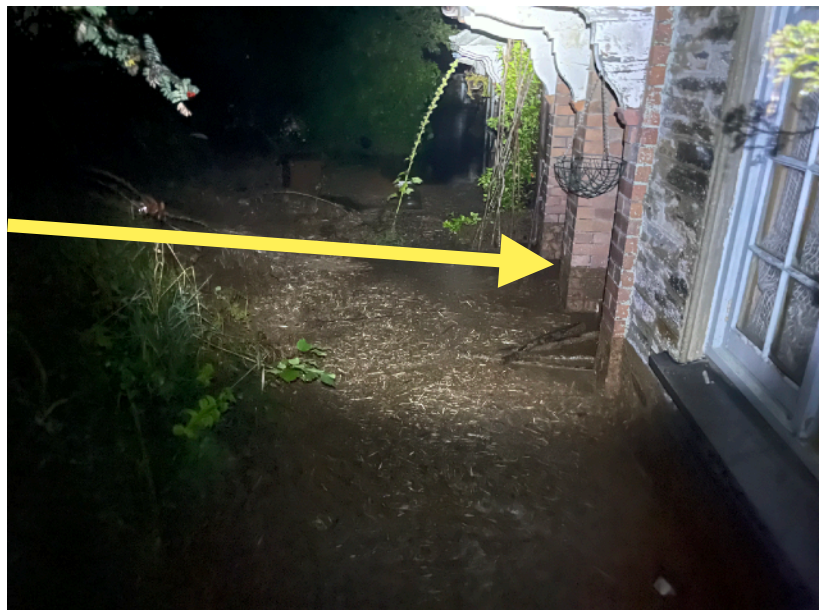
The high water mark on the doorframe brickwork is 4 bricks above the level on this photo taken at 03:09 which is 39 minutes after the peak rainfall measured on the rain gauges, so good correlation.

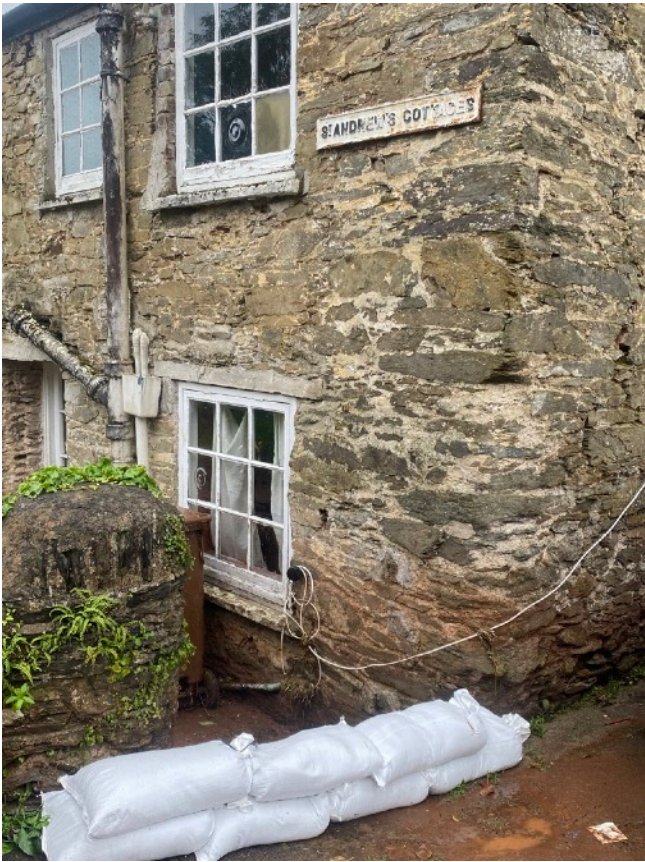
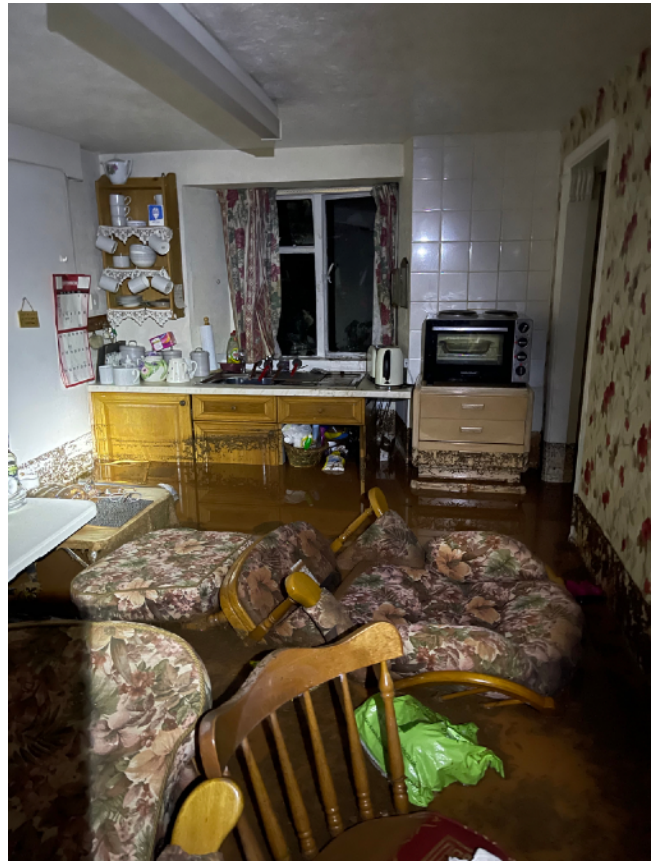
5.2.10 The flow passed around both sides of St Clement's Terrace, taking wheelie bins down Tristford Road. It carried on south, heading down Fore Street, crossing the road to flood St Andrew's cottages from the western gateway where the sandbags are in this photo.

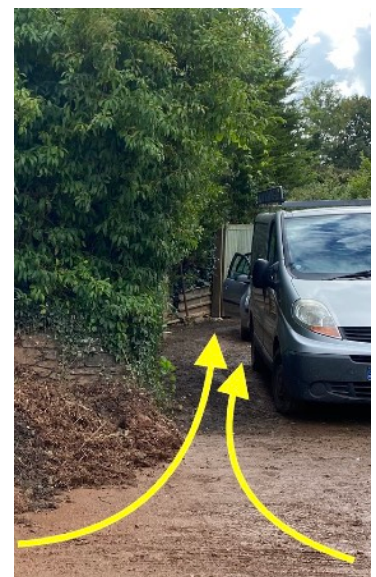
The lowest properties along the southern edge of Vicarage Ball suffered with the flow passing through, around and past them. The road camber protected northern driveways e.g. Globe House. Wesley House and no 4 & 5 St Andrew's cottages escaped lightly.

Fortunately this resident's drive was designed as a spillway when the old cow track was lowered to build the two houses.

He was woken and opened these gates, increasing the rate of spill to the stream at the rear.

His house was spared, those either side were not.

This thinking needs to be applied to all the checkpoints of this flood. Spillways do not have to be grand concrete chutes, just graded slopes that are kept clear.

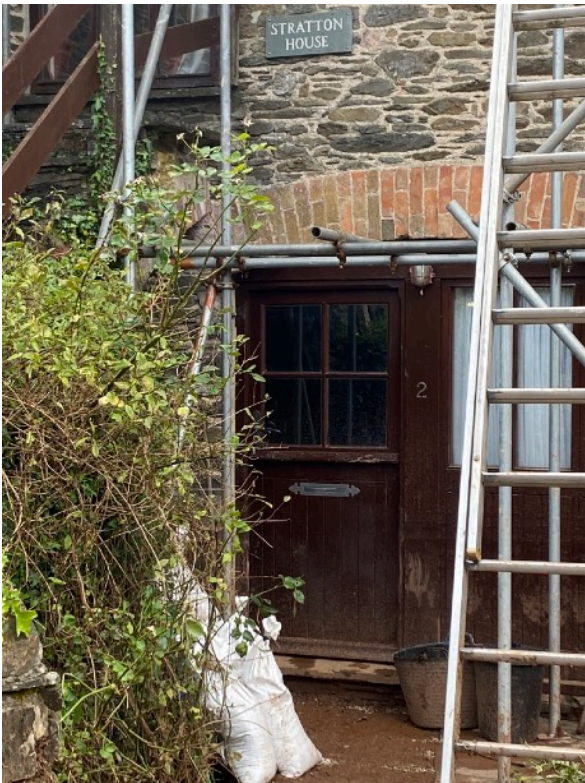
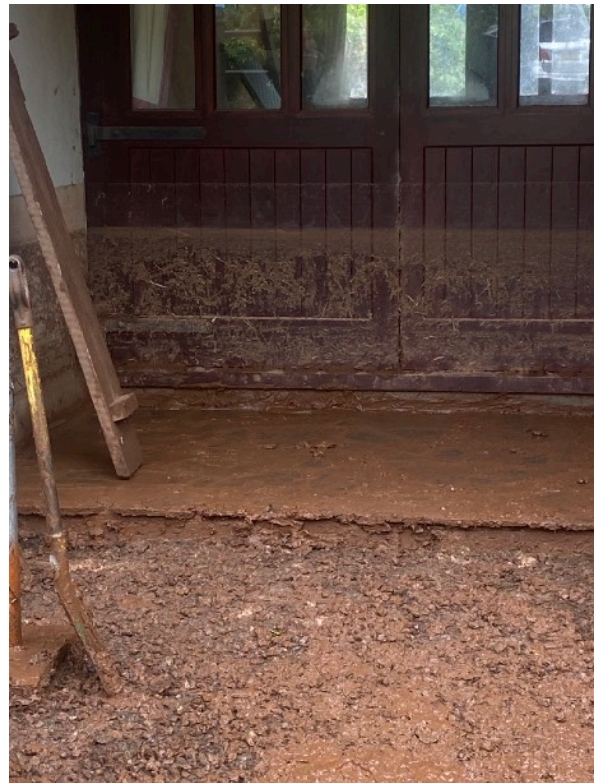
5.2.12 Preston barns 'U' shaped courtyard had the lowest affected properties and now perhaps the more challenging mitigation for future floods as the original archway has been in-filled.

9.1.3 Preston Barns need specialised attention, with a flow path to the stream to the rear

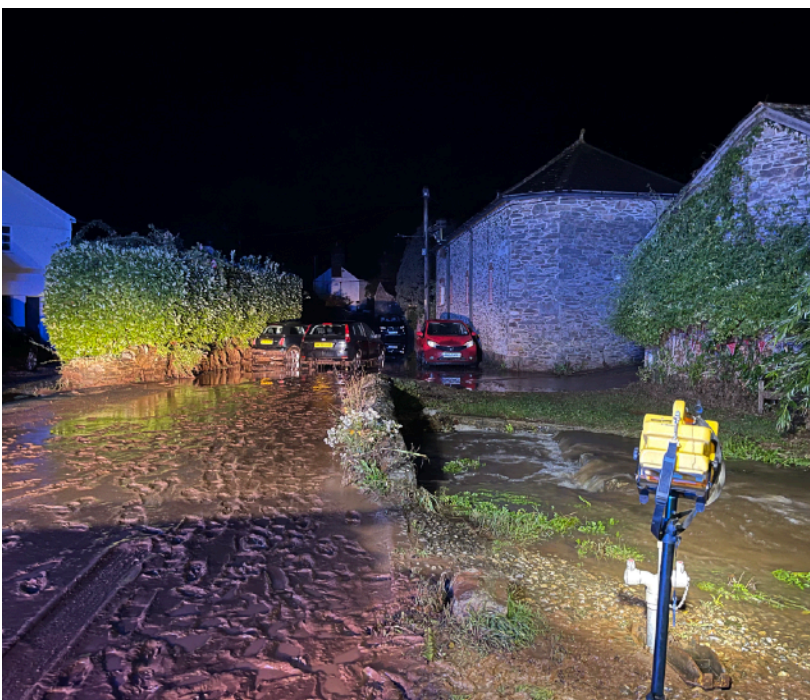
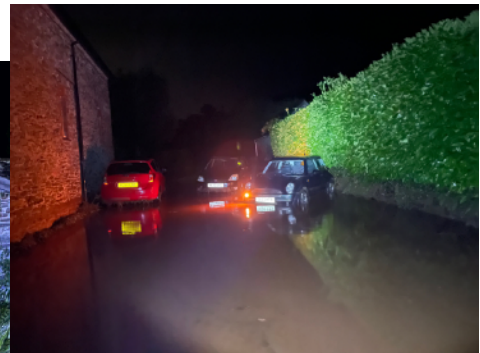
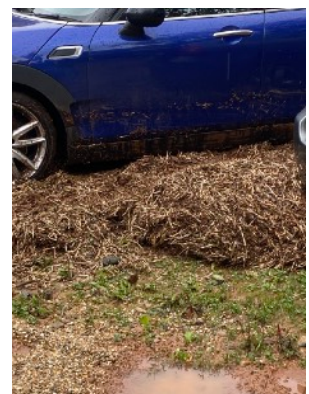
Note the flow did not reach the second stream entering the village from the east. This is a completely different system from a different valley. The stream was full, but contained within its banks. The mud on the road here came from the west, not the stream from the east.

The flow was sufficient to lift and move cars.

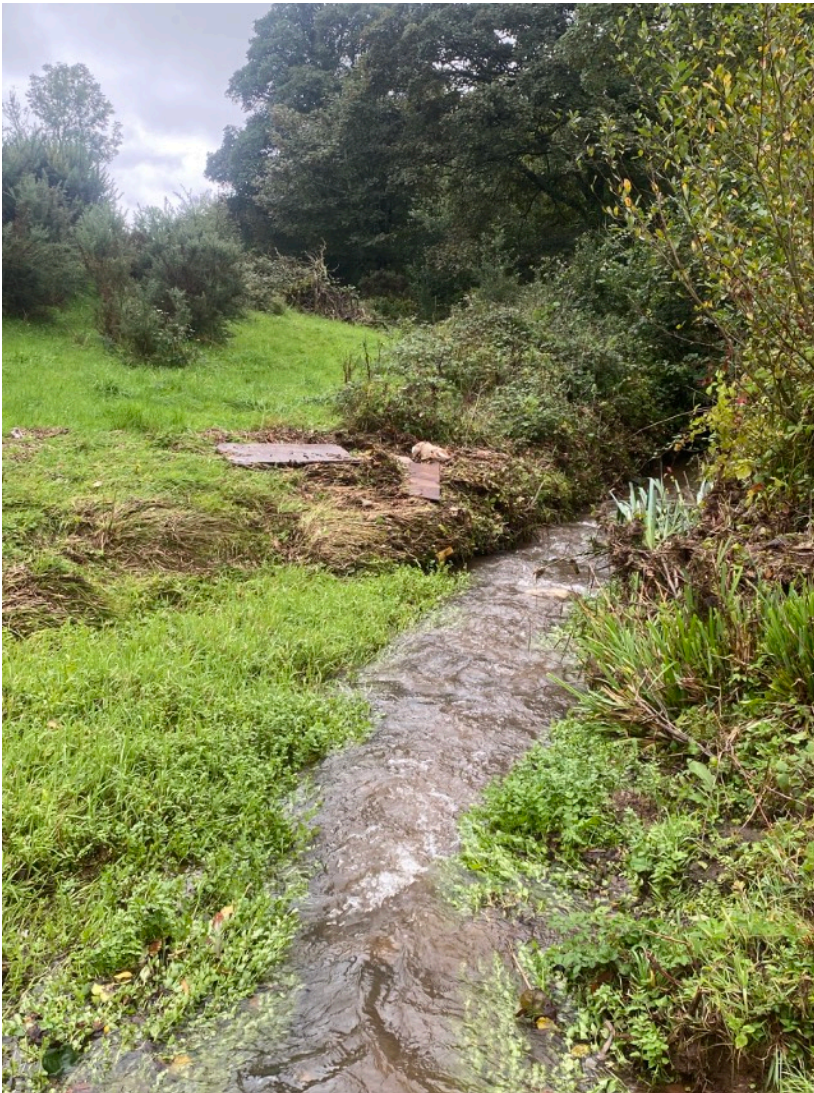
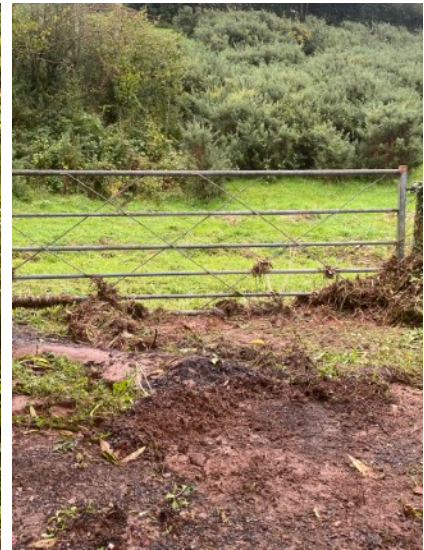
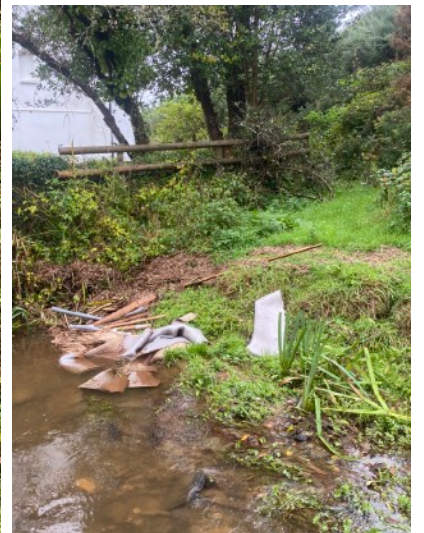
5.2.13 The final chokepoint was the narrowing of the stream heading down to the sewage works to the south of Vicarage Ball.

The waterline / scouring mark can be seen on the southern bank and gate rails.

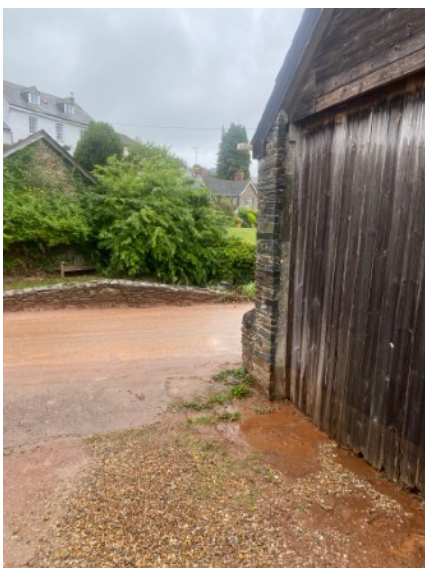
There was only a few traces of mud and straw in the garden of the Old Forge. Presumably this was caused by the stream's chokepoint above causing a backing up against this garage door. The Old Forge did flood as it sits lower than this garage.

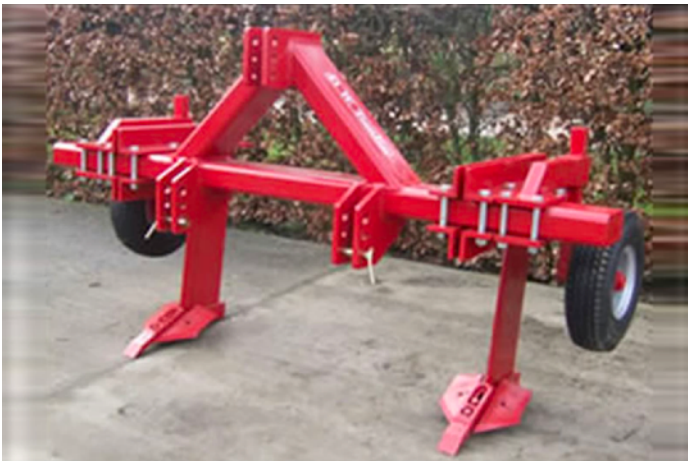
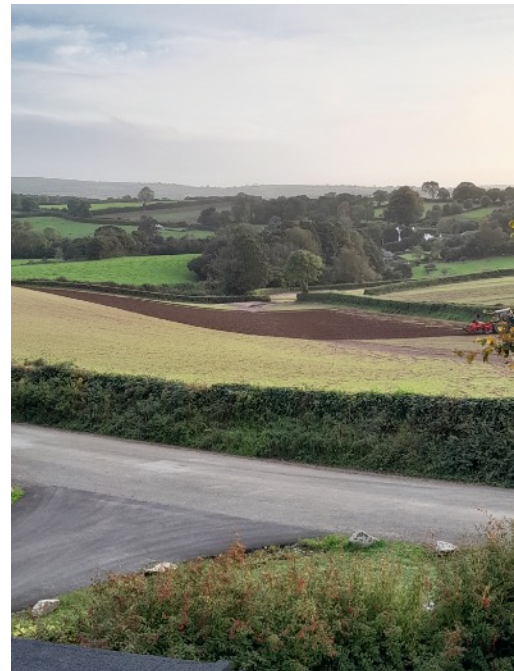
An example of a sub-soiler being used in one of the fields above Screw Lane several days after the event. The work is along the contour lines of Field 3.

The deep blades break and lift compacted sub-soil
