Flood Investigation Report

Devon Floods 17 September 2023

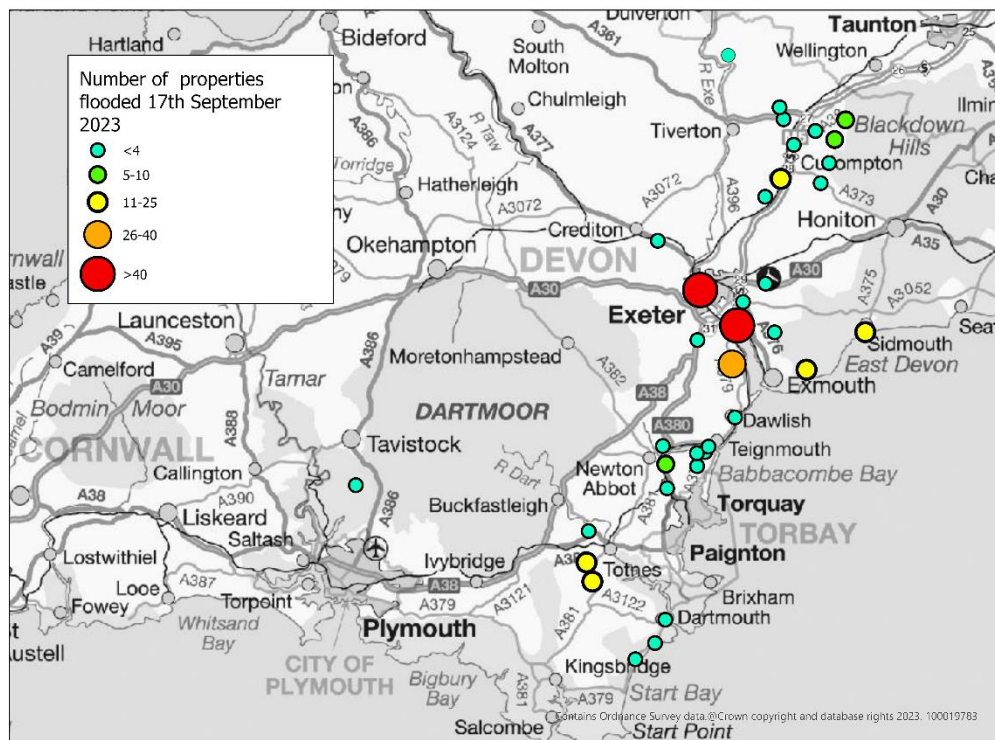
Figure 3.1. Extent of the flooding across Devon on 17th September 2023.

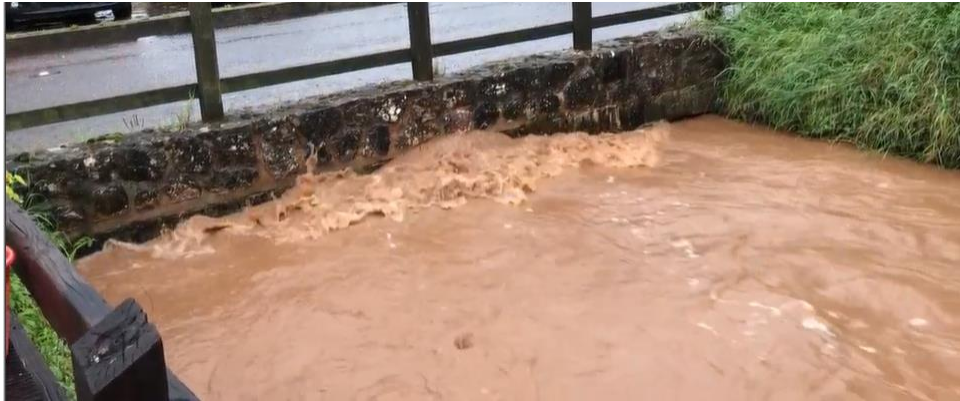
Figure 4.2. Still image taken from resident's video showing flows on the River Weaver above the soffit level of the A373 bridge in Dulford.

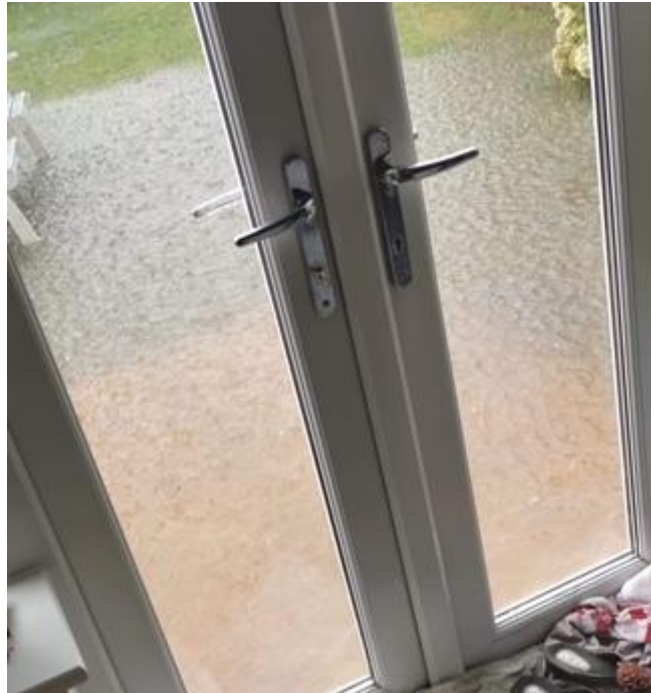
Figure 4.5. Photo showing some of the external levels outside the property off Young Acres Road which experienced internal flooding (Credit: Local Resident).

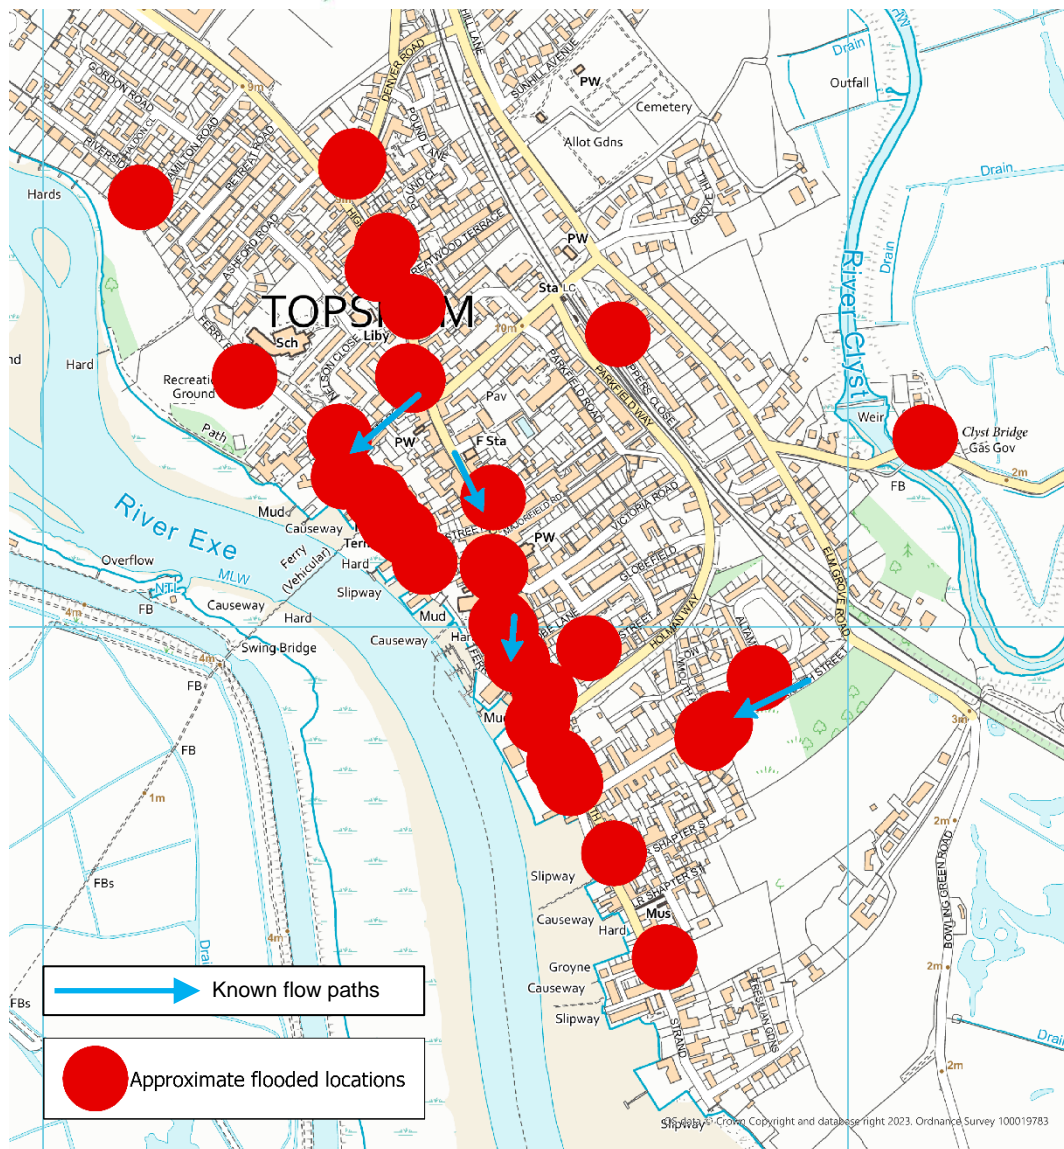
Figure 5.2. Approximate extent of flooding and known flow paths in Topsham on 17th September 2023.

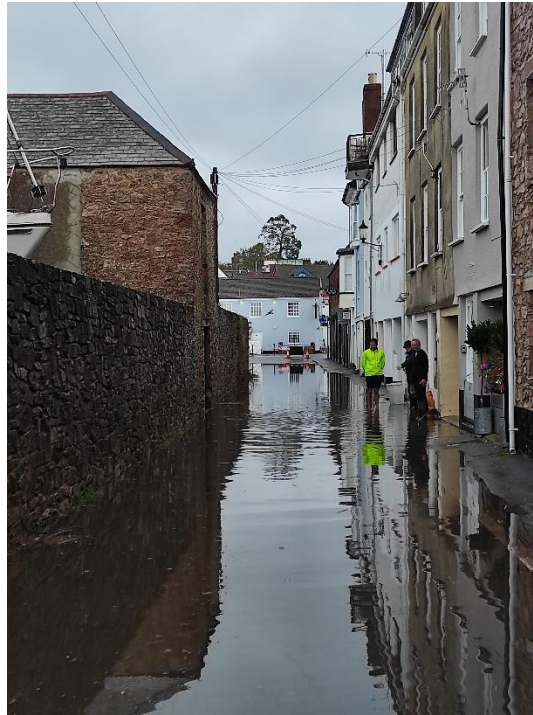
Figure 5.3. Flood waters receding on The Strand, Topsham. Credit: Topsham resident

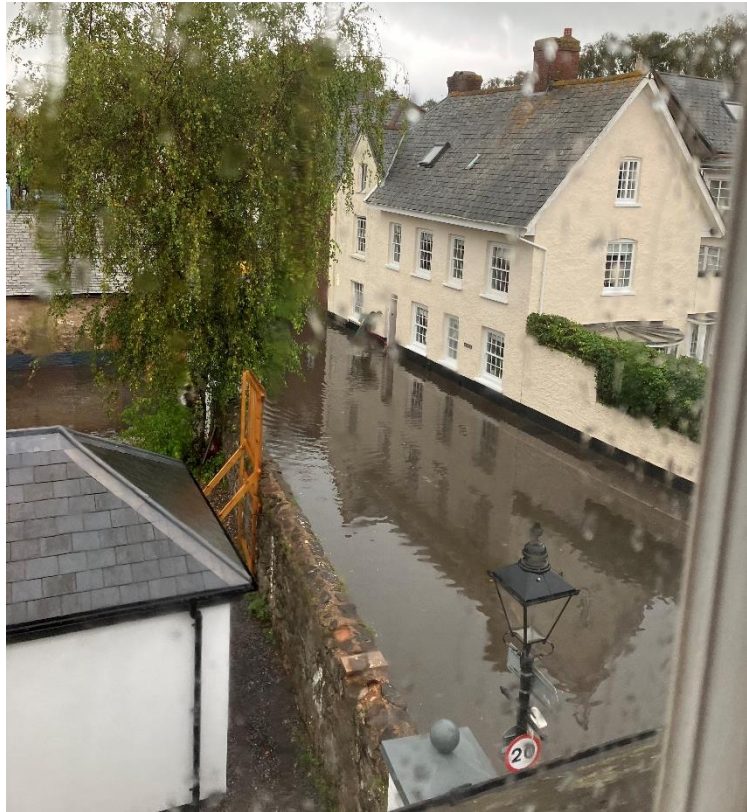
Figure 5.4. surface water on Ferry Road, Topsham 17th September 2023. Credit: Topsham resident

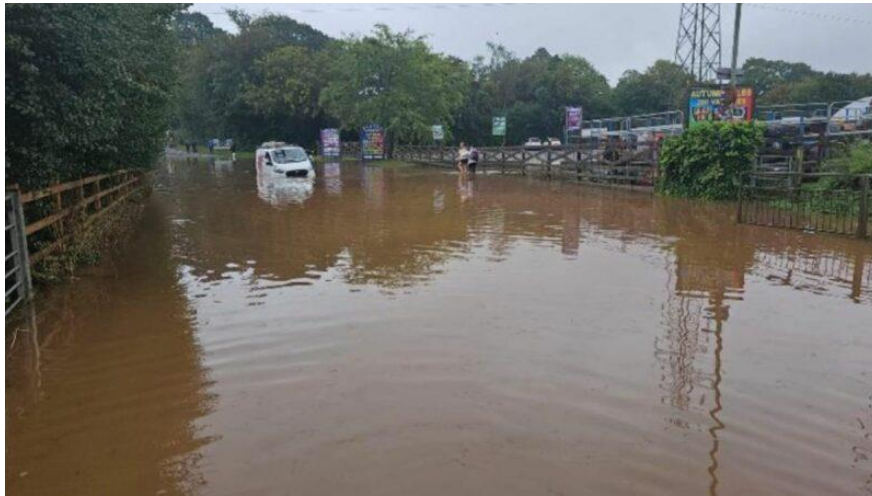
Figure 5.5. *Flooding on Topsham Road (DCC News)*

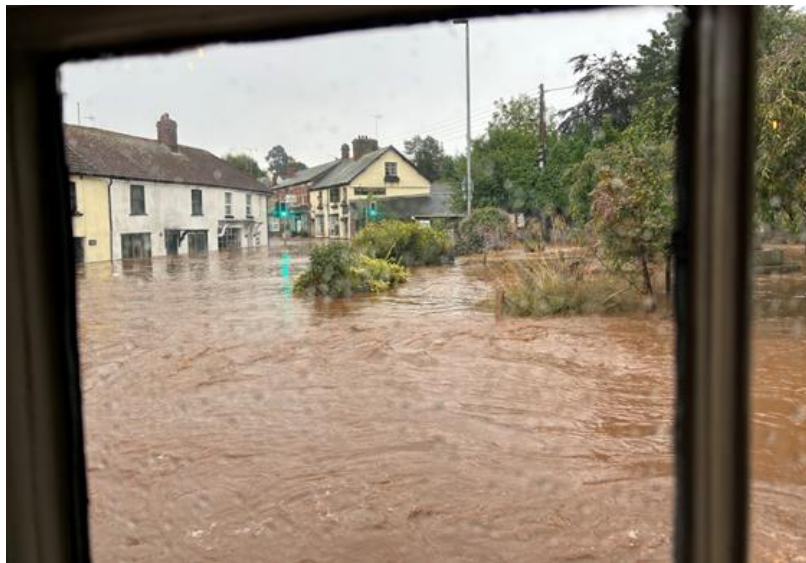
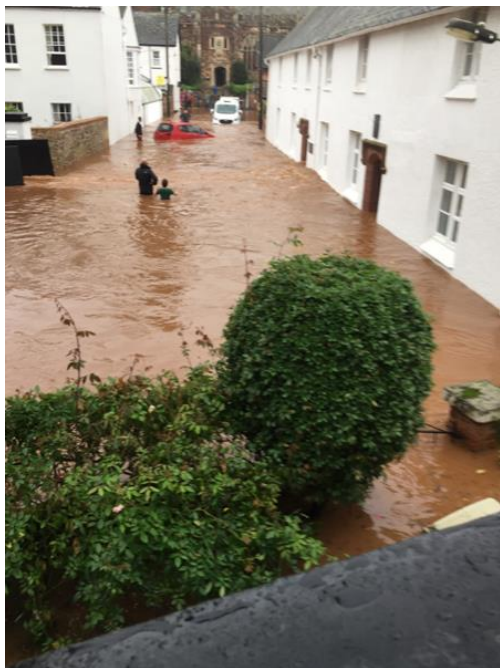
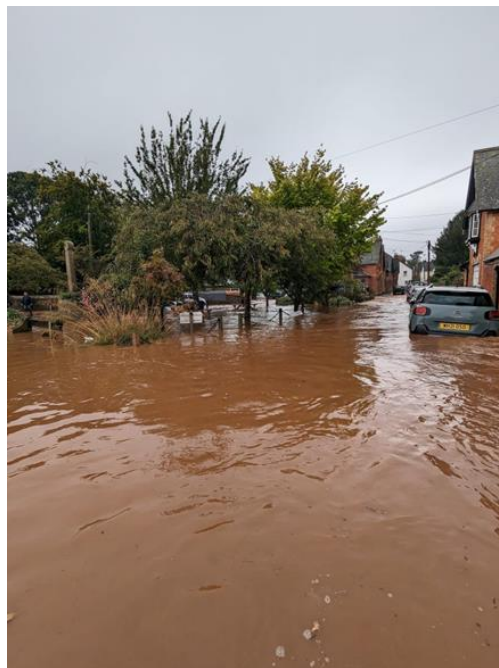
Figure 6.2. Images of the flooding impacts in Kenton on 17th September

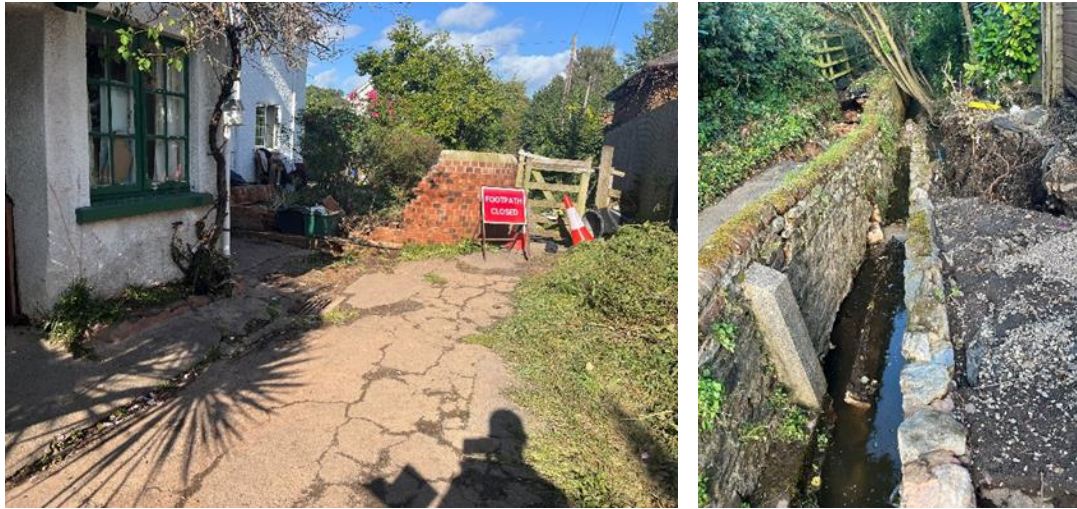
Figure 6.3. Damage caused to the footpath in Kenton.

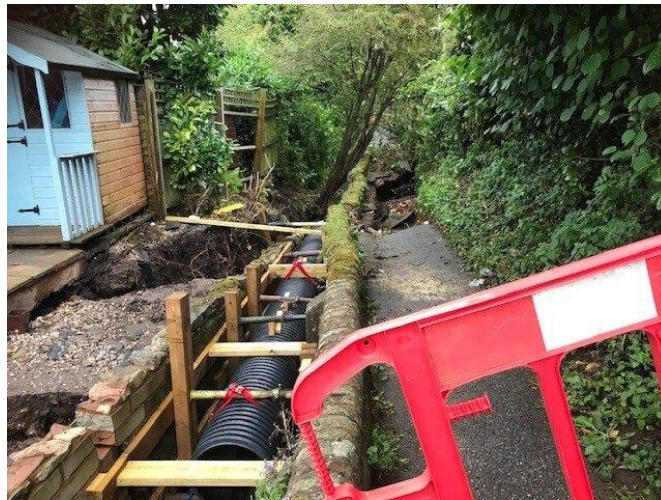
Figure 6.4. Temporary works on the watercourse to support the footpath in Kenton and maintain flow in the brook.
