Tree Condition Assessment Prepared for

Harberton Parish Council Parks and Green Space

Client:	Harberton Parish Council – Cat Radford	Ref:	AK/754/170925
Location:	  Harberton Playing Fields, Harberton, Totnes, Devon   Harbertonford Playpark, Harbertonford, Totnes, Devon.		
Date of site Inspections:	8 th September 2025		
Survey Inspector(s):	Aran Kimberlee BSc (Hons) Arboriculture, PGCert Ecology, M Arbor A, PTI, Vet Cert.		
Report Author:	Aran Kimberlee BSc (Hons) Arboriculture, PGCert Ecology, M Arbor A, PTI, Vet Cert.		
Signature:	 	Date:	17 th September 2025

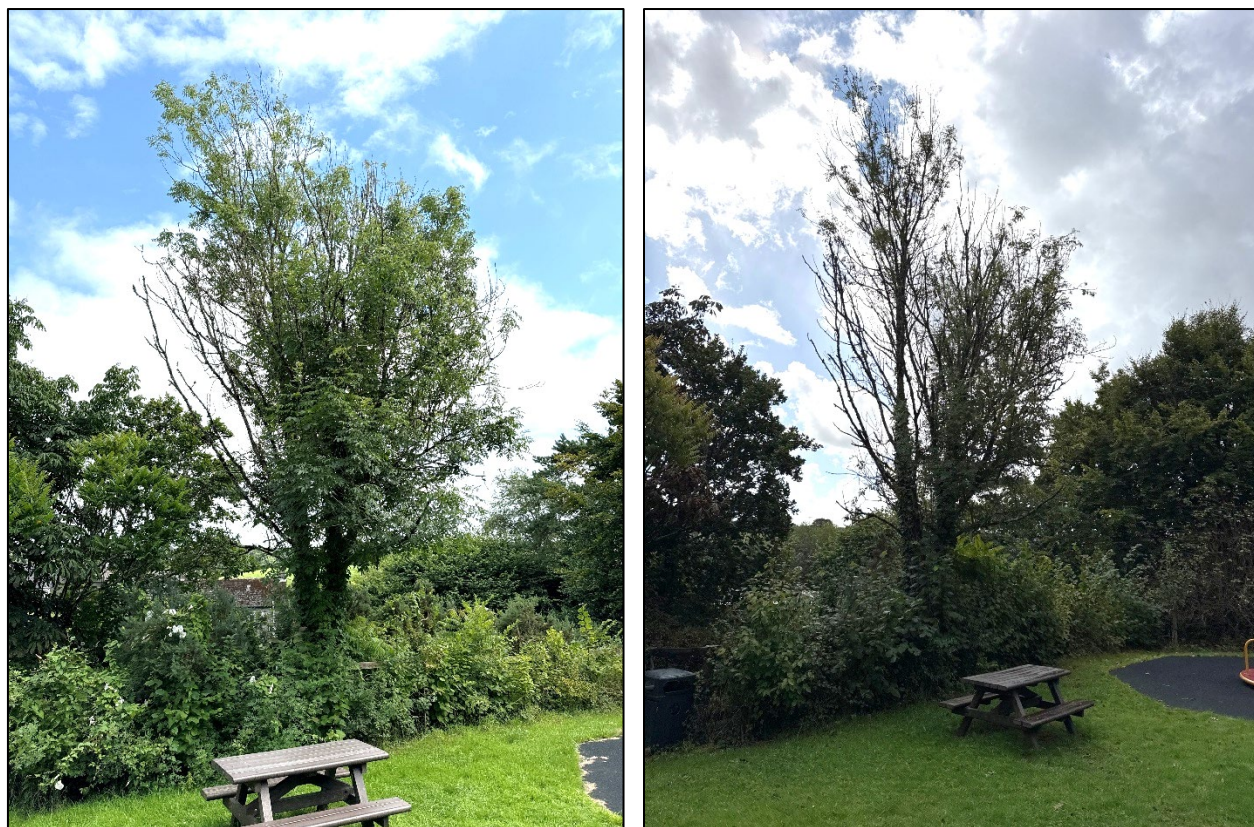
However, the small ash tree adjacent to the main playpark (T1485) has been in decline for several years, with symptoms of dieback worsening annually. Although still assessed as a Broadly Acceptable risk, I recommend pollarding this tree, reducing the trunks to a height of 2–3 metres to allow potential regrowth as a smaller specimen. This work should be undertaken as resources (funds and time) permit.

Photographs 1 and 2: ash tree T1485 with ADB 2024 and 2025 (right).

Tree No.	Location	Species	Observations	Recommendations	Work Priority
T1485	Harberton Playing Fields	Ash	<ul style="list-style-type: none"> Progressively in poorer physiological condition than when viewed in 2024. 	<ul style="list-style-type: none"> Consider pollarding at 2-3 metres in height. 	Low – Works recommended to be carried out whenever budgets allow.
C1	Harbertonford play park	Mixed Broadleaf	<ul style="list-style-type: none"> Ornamental and self-seeded specimen trees around play park equipment. Oak at main gate has low overhanging branches 	<ul style="list-style-type: none"> Crown raise low branches at park gate entrance up to 2.5 m from ground level. 	Low – Works recommended to be carried out whenever budgets allow.
T1485	Harbertonford play park	Ash	<ul style="list-style-type: none"> Progressively in poorer physiological condition than when viewed in 2024. 	<ul style="list-style-type: none"> Consider pollarding at 2-3 metres in height. 	High- Risk is unacceptable and remedial works should be carried out within 2 months.

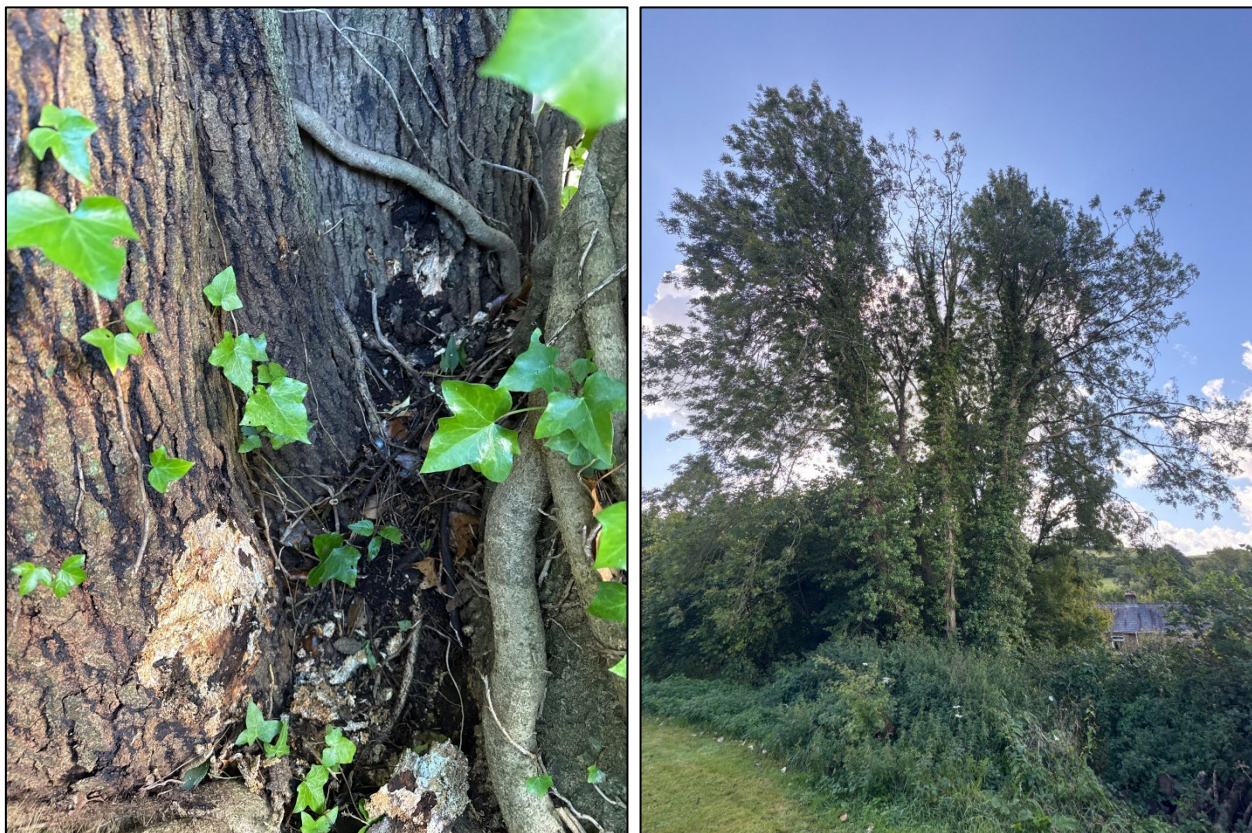
- 4.2.3 Compartment 2 contains several larger boundary trees, historically coppiced, growing along the southern and western boundaries. On the southern boundary is a historically coppiced ash (now tagged 1485) with multiple stems arising at ground level. The easternmost stem has a significant bark inclusion where it adjoins another stem. In a previous survey (2020), movement was observed at this union, and a reduction of the ash group was recommended. These works were subsequently carried out.

However, during this inspection, significant basal decay was identified at the base of the stems, with cambial dysfunction extending upwards on the inner sides. Approximately three stems lean towards neighbouring gardens and property, increasing the risk of failure, particularly following the necessary coppicing of adjacent sycamores in 2024. I therefore recommend that all five stems are pollarded or high-coppiced, leaving stumps at approximately 2 metres in height.

Photographs 3 and 4: T1485 ash coppice showing decay at base of stems (let) and view of trees (left).

Tree No/ ID	Tree Species	Age Range	Height (m)	Spread (m)	Stem Dia. (mm)	Structural Condition	Vitality	Comments	Management Recommendations	Target Range	Size Range	PoF	Risk Index
C1	Mixed Broadleaf	EM	Up to 10	-	Up to 250	G	G	<ul style="list-style-type: none"> Ornamental and self-seeded specimen trees around play park equipment. Oak at main gate has low overhanging branches 	<ul style="list-style-type: none"> Crown raise low branches at park gate entrance up to 2.5 m from ground level. 	2	2	6	<1M
C2	Mixed broadleaf- Sycamore, Ash, Hazel, Willow	M	Up to 21	-	Up to 450	M	G	<ul style="list-style-type: none"> Area of historic coppiced ash and sycamore growing on southern and western boundary. Sycamore stem in group with basal decay. Ash recently reduced. No change in condition of trees 	<ul style="list-style-type: none"> No works required. 	3	2	6	<1M
T1484	Ash	M	21	10	Up to 320	P	M	<ul style="list-style-type: none"> Old coppice stool with 5 stems arising from ground level. Previously reduced due to stem with included union. Stems significantly decayed at base of at least three stems, including two leaning towards neighbouring property. 	<ul style="list-style-type: none"> Fell/ high coppice all 5 stems leaving a finished height of approx. 2 metres. 	2	2	3	10K
