## Ordinary Meeting of Harberton Parish Council Tuesday 14<sup>th</sup> November 2023

## Item 10: Flooding in Harberton Parish

## **Harberton Flood**

# 17th September 2023

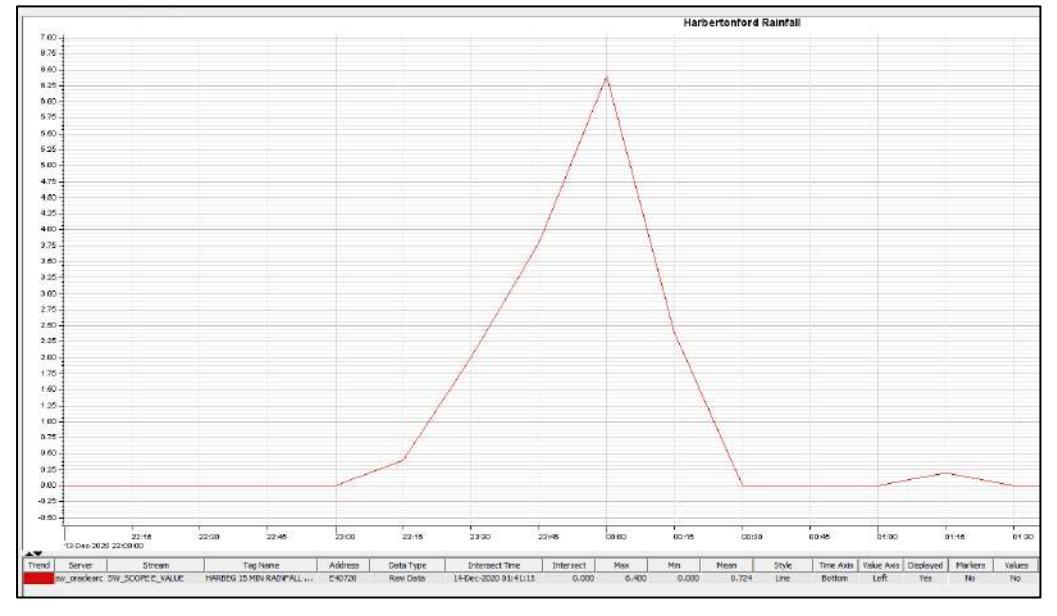
## December 14<sup>th</sup> 2020 Flood rainfall:

Peak intensity 6.4mm per 15 min. This equates to 25.6 mm per hour. Total = 15mm in 1.5 hours

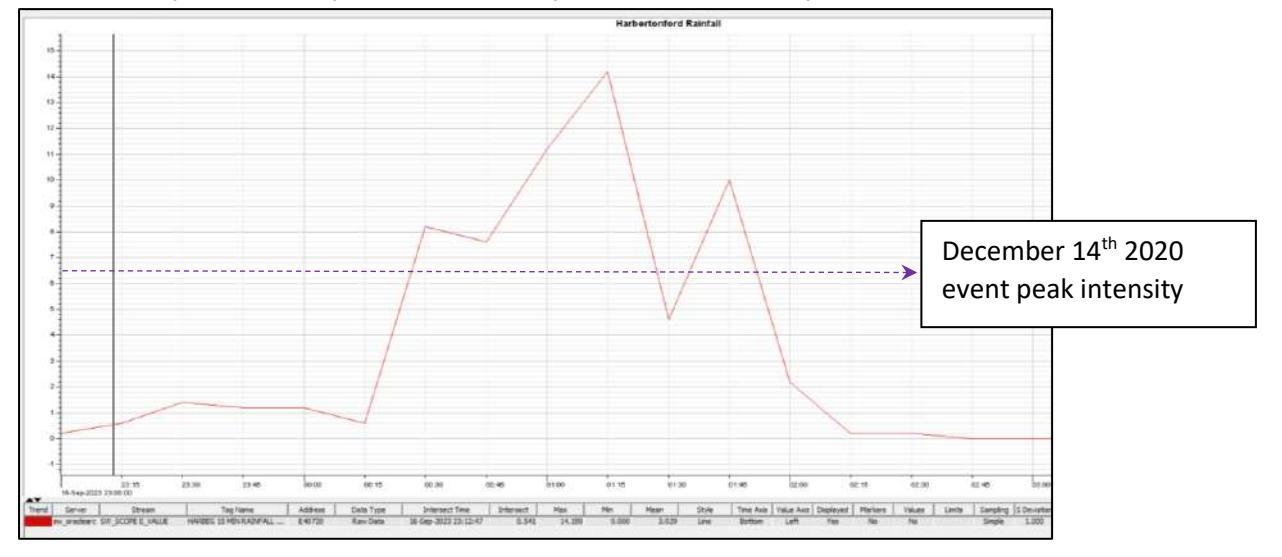
## September 17<sup>th</sup> 2023 flooding:

Peak intensity 14.199 mm per 15 min. This equates to 56.796 mm per hour. Total = 60mm in 2 hours.

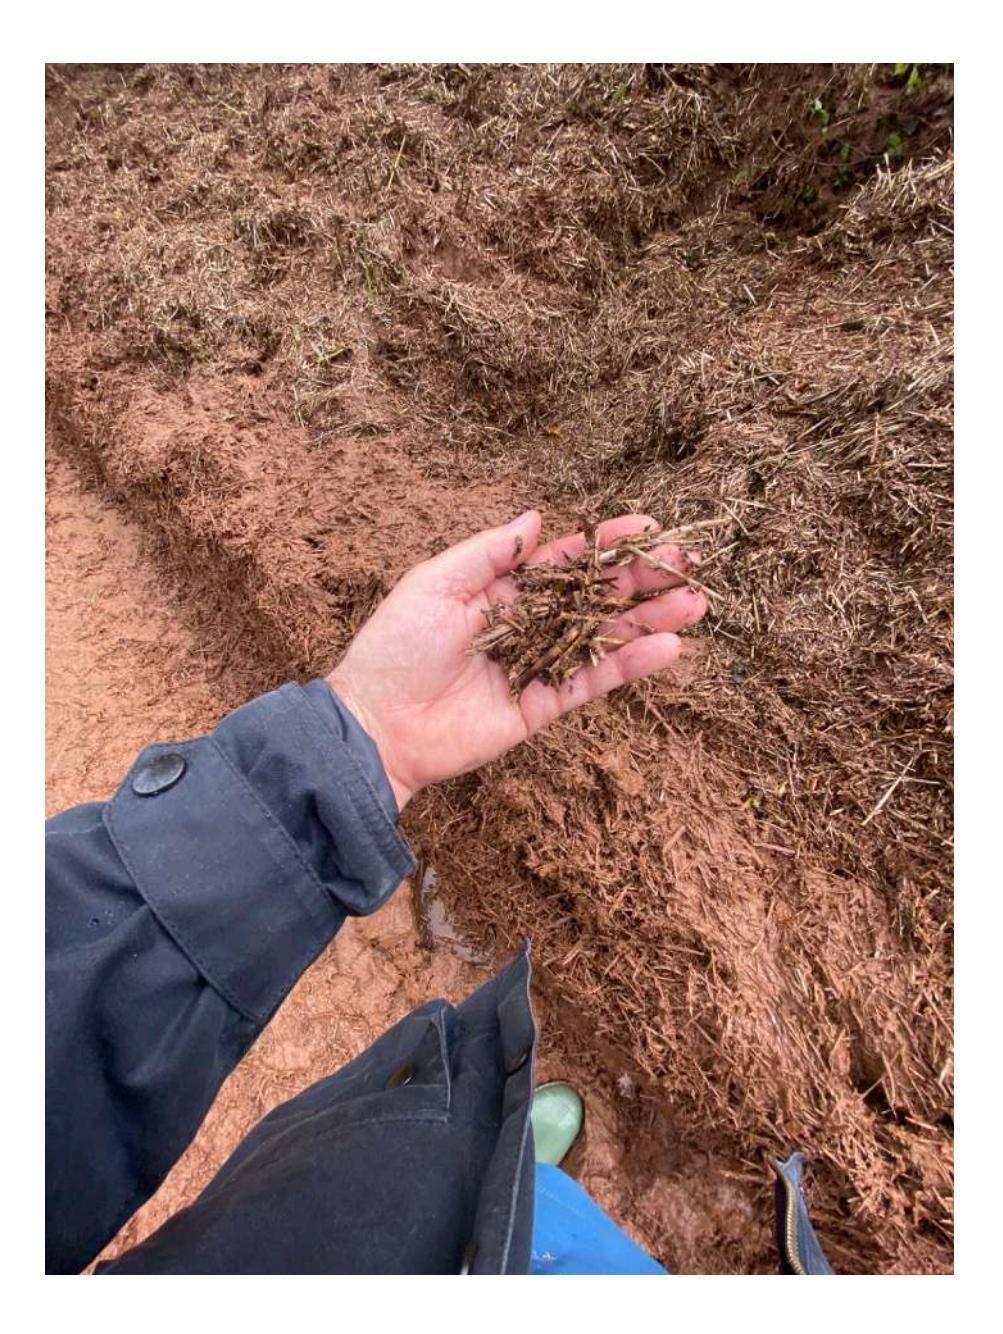
The flood stream consisted of water-borne mud and chopped straw.

The fields north of Screw Lane had been minimally tilled in line with current farming practice. This resulted in short lengths of straw on a shallow bed of tilled dry soil, with a compacted soil subbase.

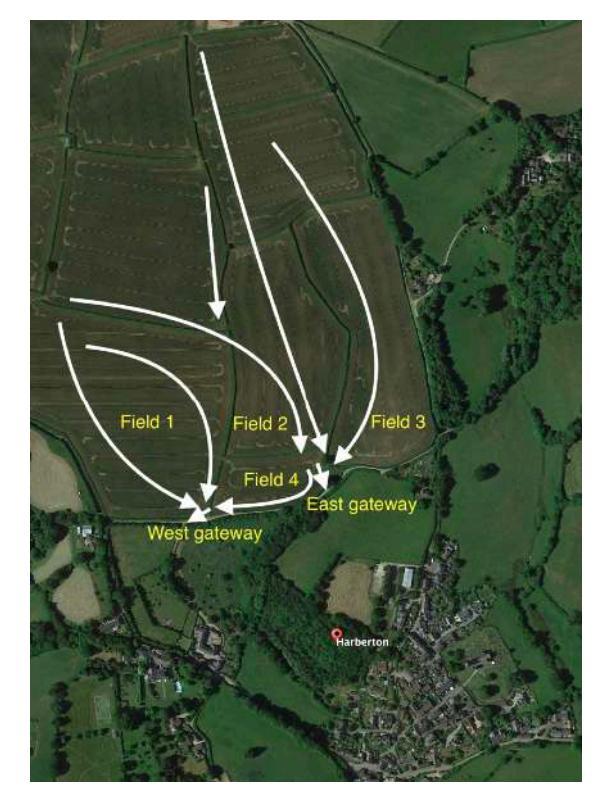
5.2.1 The water ran down the fields north of Screw Lane. Fields 1,2,3 and 4 were freshly tilled, the others to the north had a well-established crop.

The water, mud and straw gathered against the southern borders of those fields forming the north border of Screw Lane.

The white lines show the flow paths as seen in the photographs. Detailed photos are available.

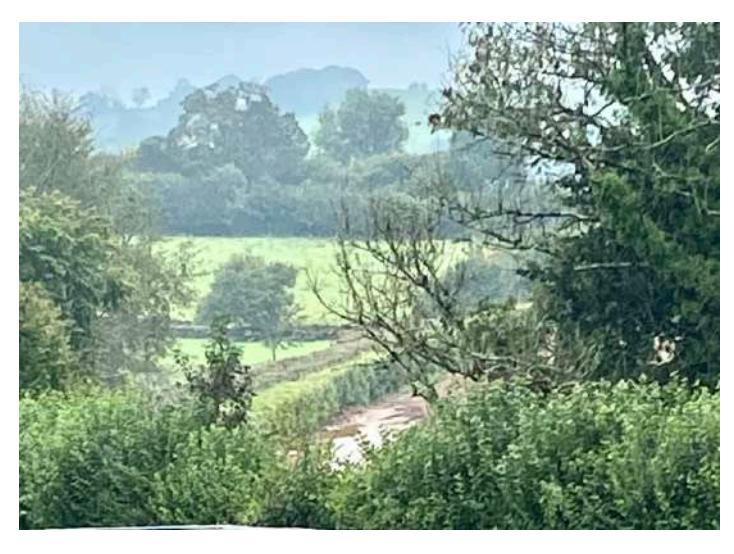
Water banked up and pooled along the fields' southern banking forming the north side of Screw Lane.

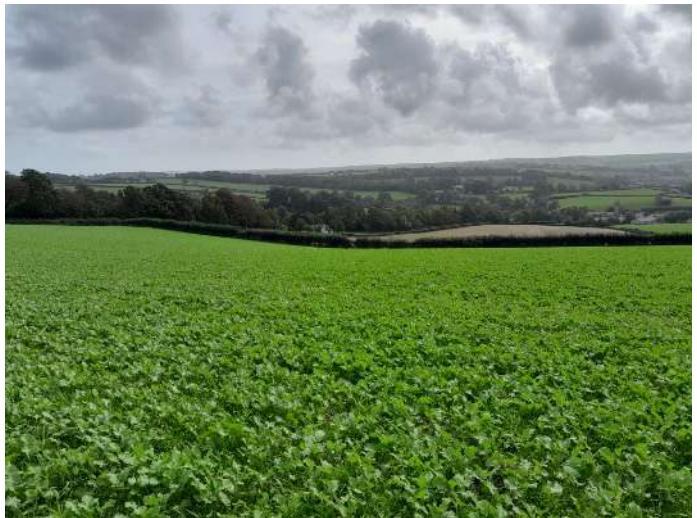
Established crop north of fields 1,2,3 and 4, looking down on the freshly-tilled and seeded fields in the far distance.

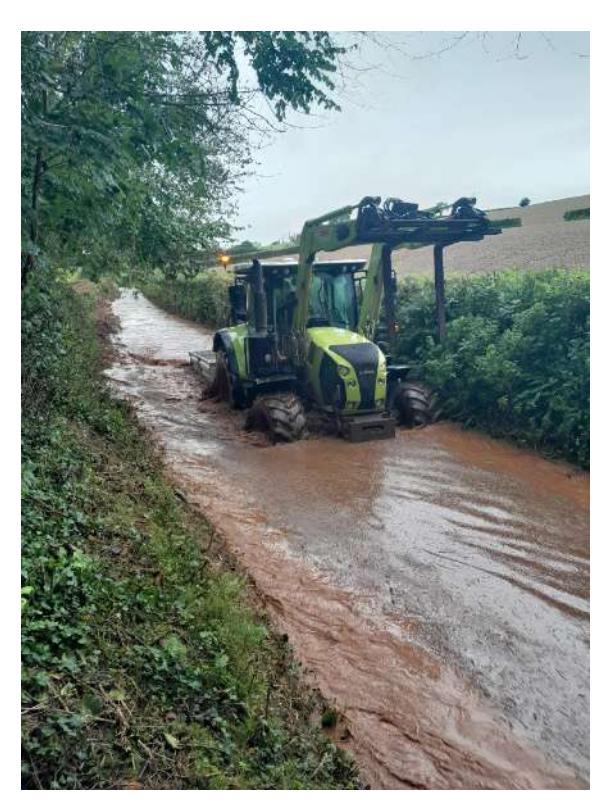
A tractor the following morning in the lower part of Screw Lane, heading east.

Note the left hand stream still running towards the tractor.

Screw Lane's hump is still submerged, 10 m behind the tractor.

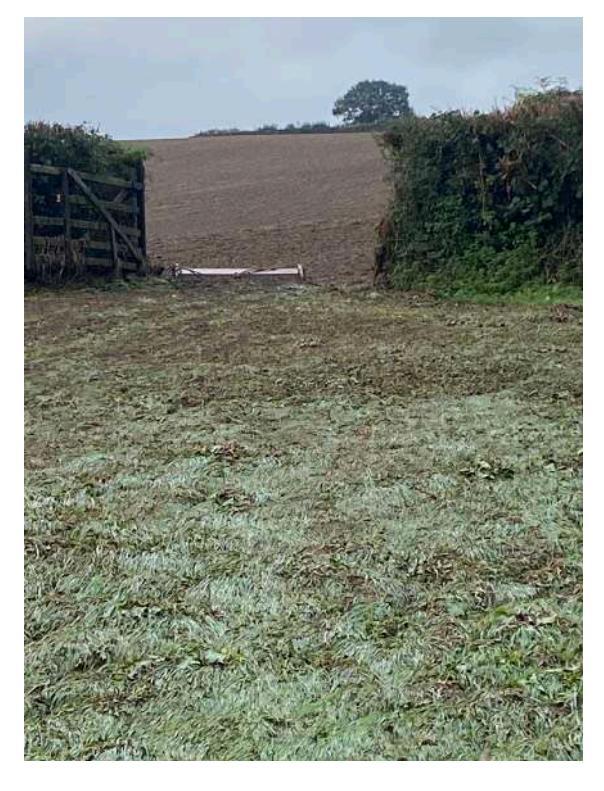
Main flow from upper field, across Screw Lane

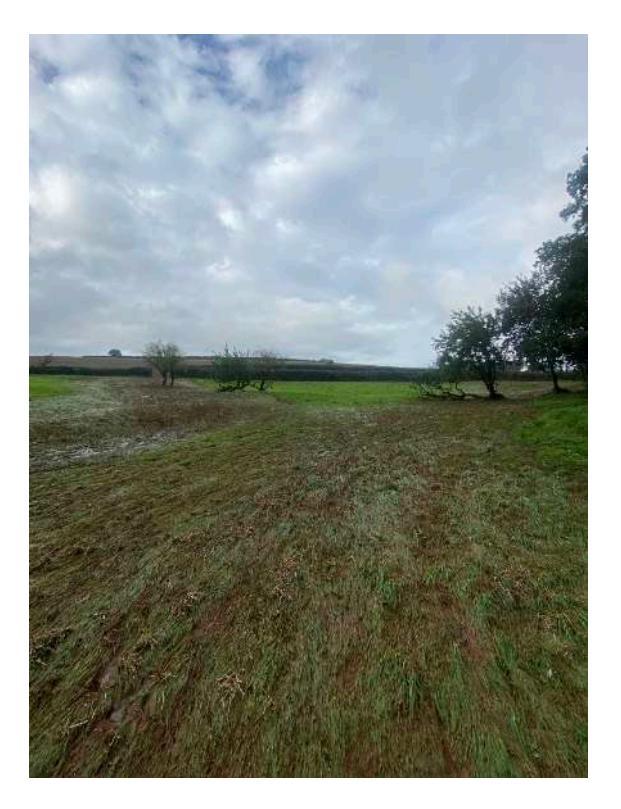
Looking north at 2 streams heading south forming a 'Y' shape

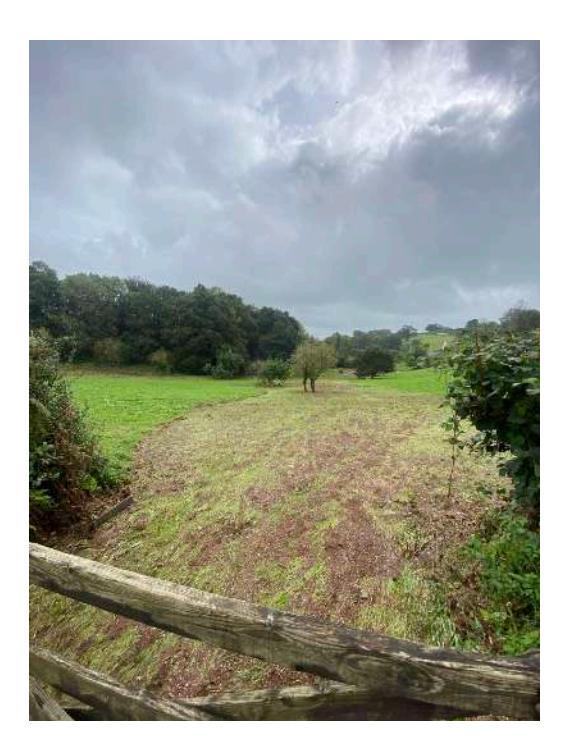
One stream heading south

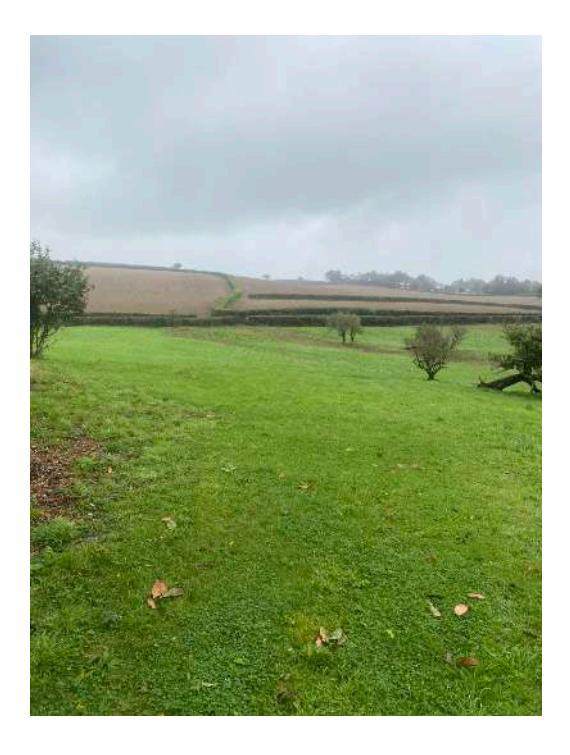
Stream with fields in upper background

This grassland had only recently been cleared of brambles and other vegetation

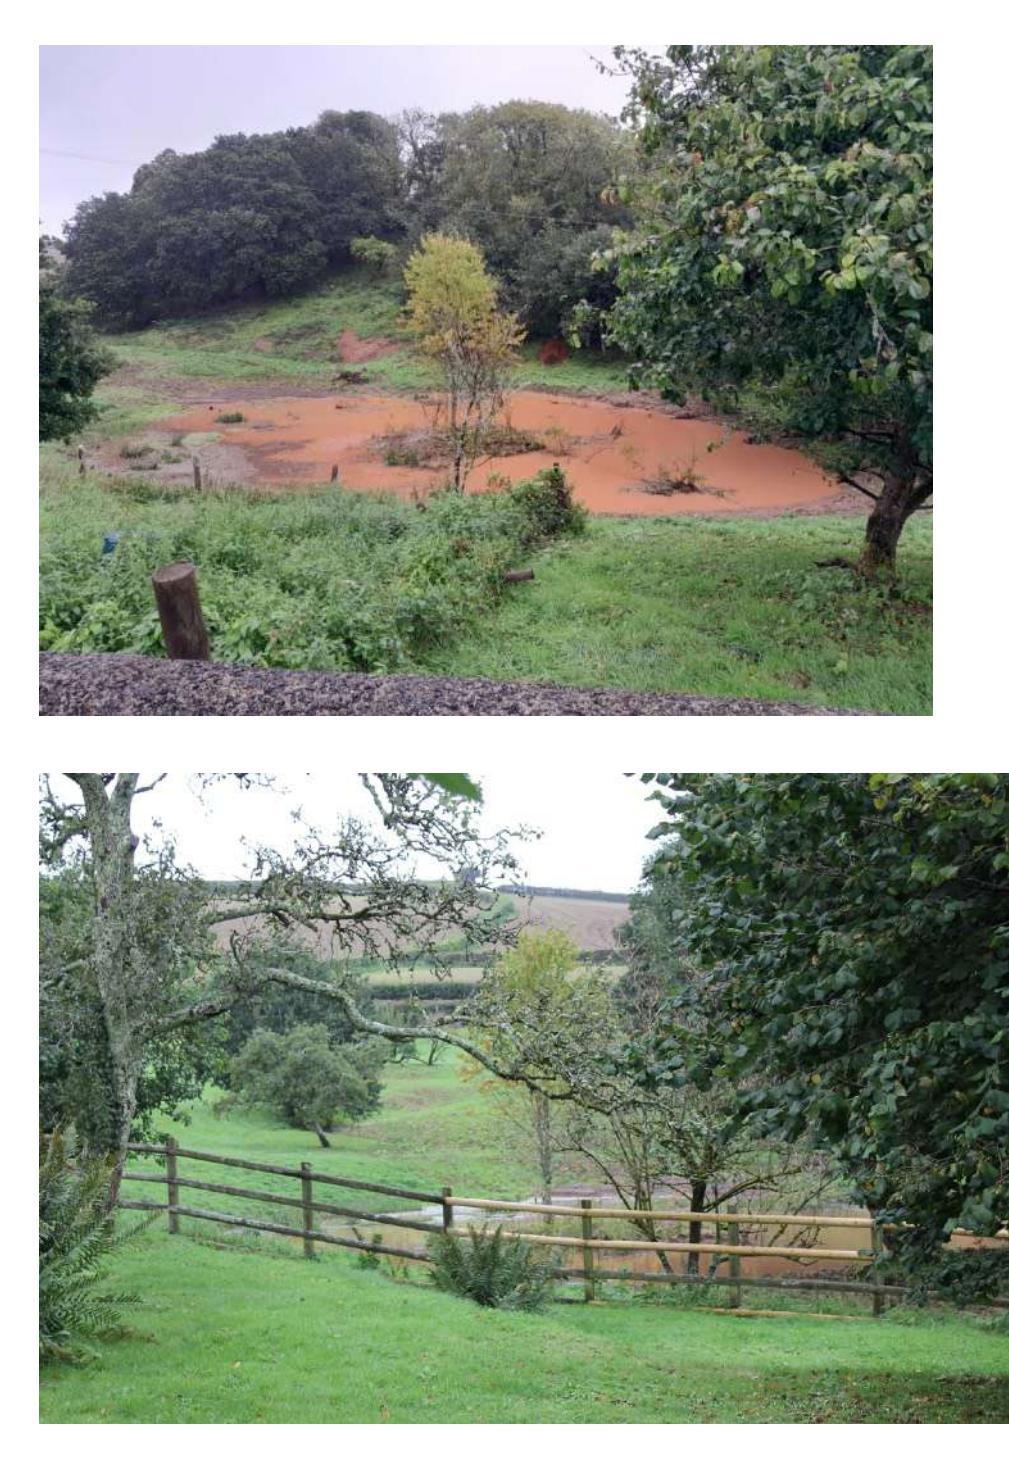
This pond was dug many years ago to act as an attenuation pool for flood water. There were plans to deepen it as it had silted up over recent years. Many years ago hurdles were placed above this pond to capture silt from above. Being shallow, the pond overflowed, but it's banks remained intact and were not scoured.

Looking north towards field 1 in the upper part of this shot, with the pond in the foreground

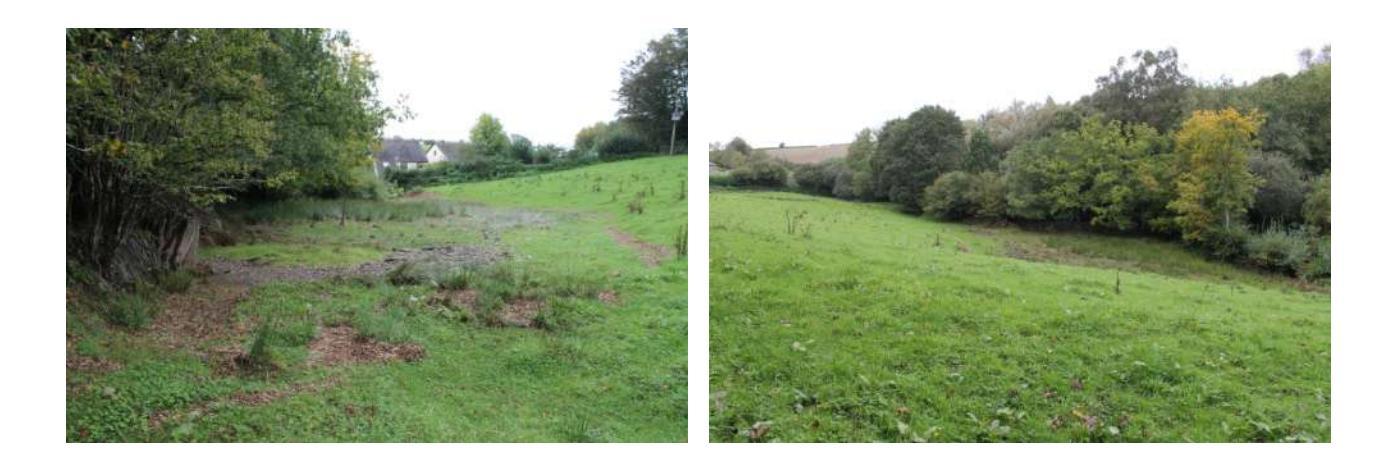
The stream has 1.5m levees on it's west bank to protect the field to the south. However there are gaps in the levee which caused spillage

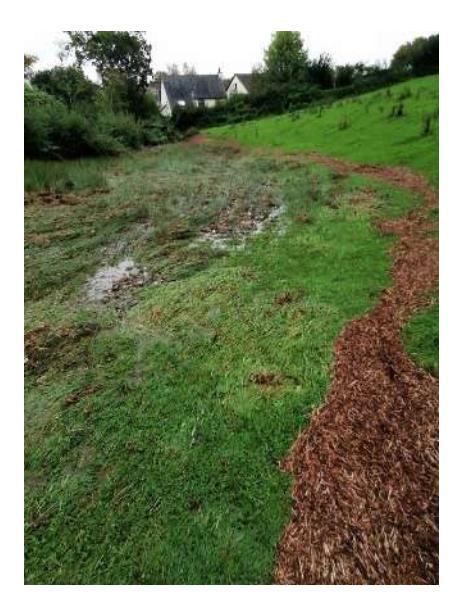
Levee gap and spillage

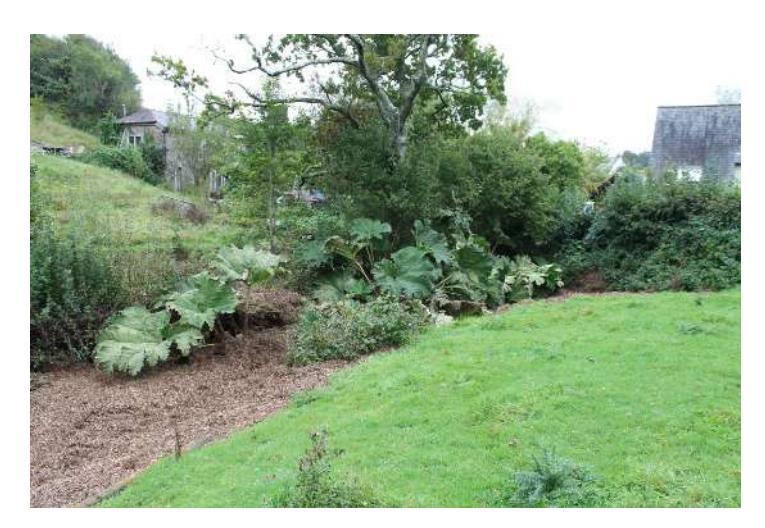
The levee spillage eastwards was significant. It backed up against the Gunnera plants behind Ashbrook Cottage

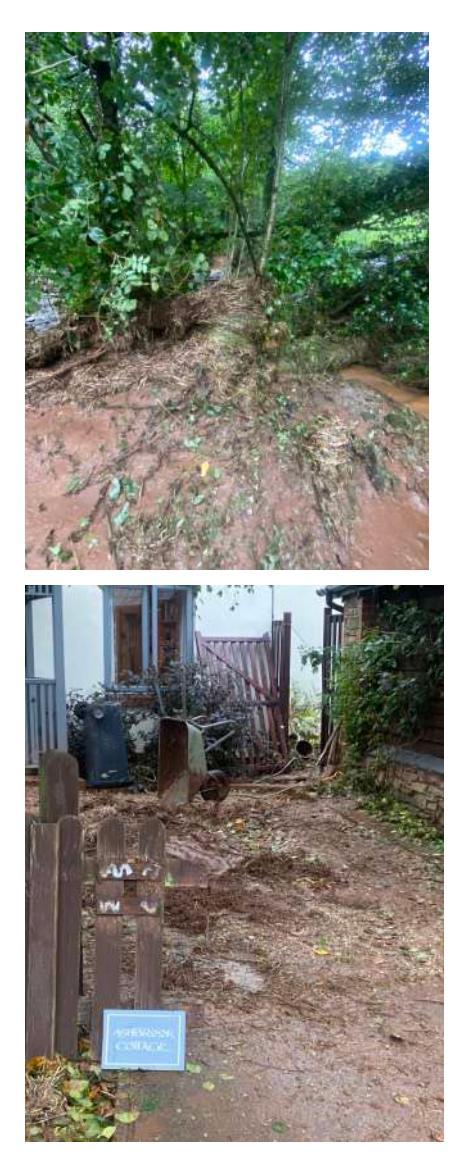
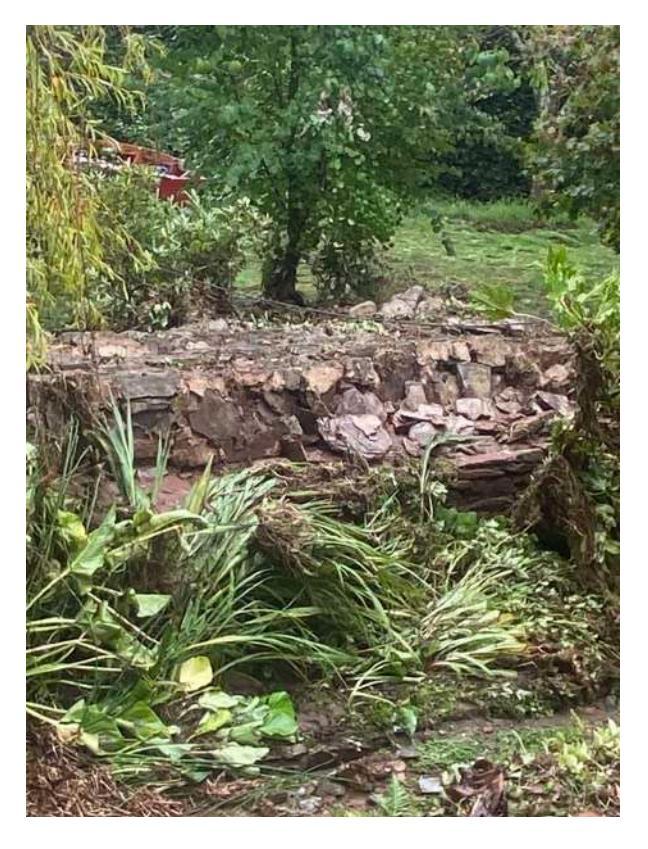
5.2.7 The stream pushed through to the side of Ashbrook Cottage where it pushed over a north wall. It spilled north to Town Farm and east along the road behind St Clement's Terrace.

Collapsed wall at Ashbrook Cottage

South east flow through Ashbrook Cottage side gateway.

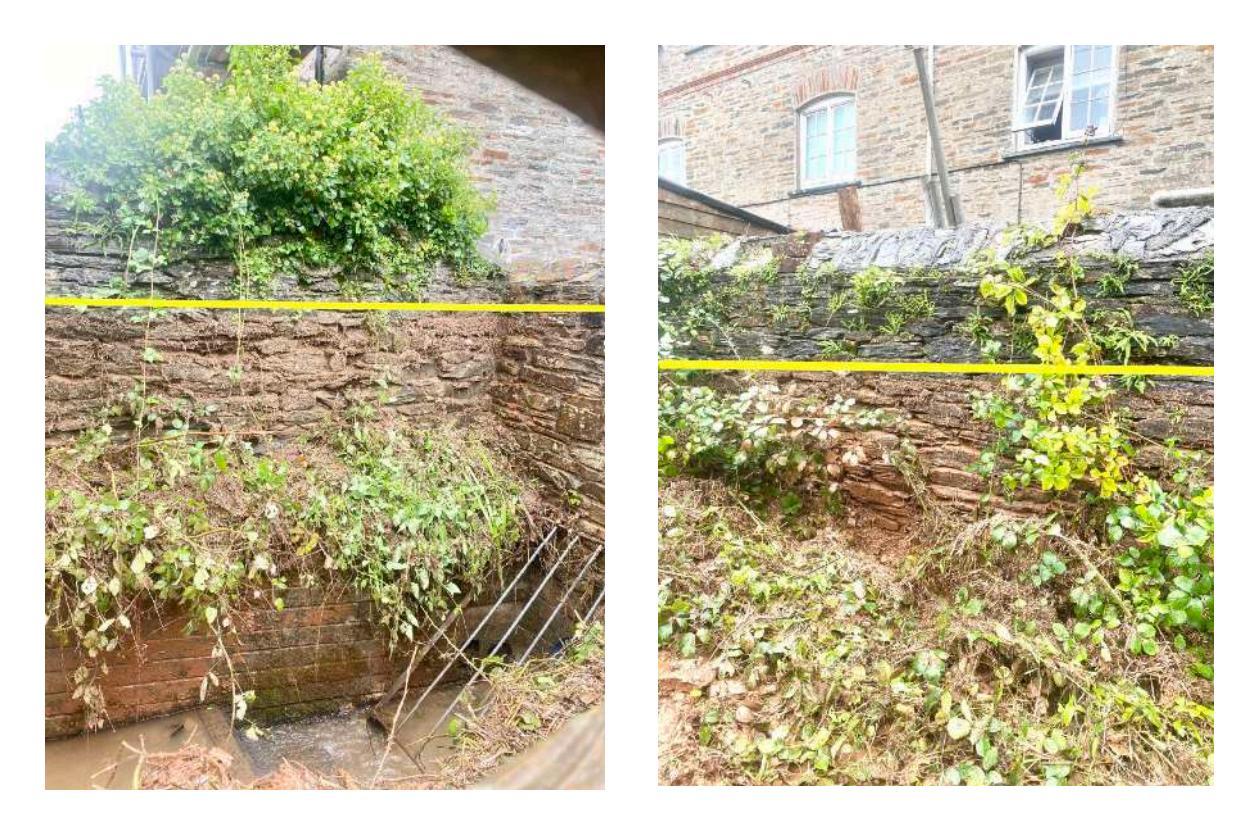
5.2.9 The main stream then ran downhill to the south. It blocked the culvert at the western end of St Clement's Terrace. Fortunately, the north wall behind St Clement's was not breached.

Note the water mark in the culvert is 250mm (10 inches) below the topping stones.

Inclined grating over the culvert

St Clement's rear wall

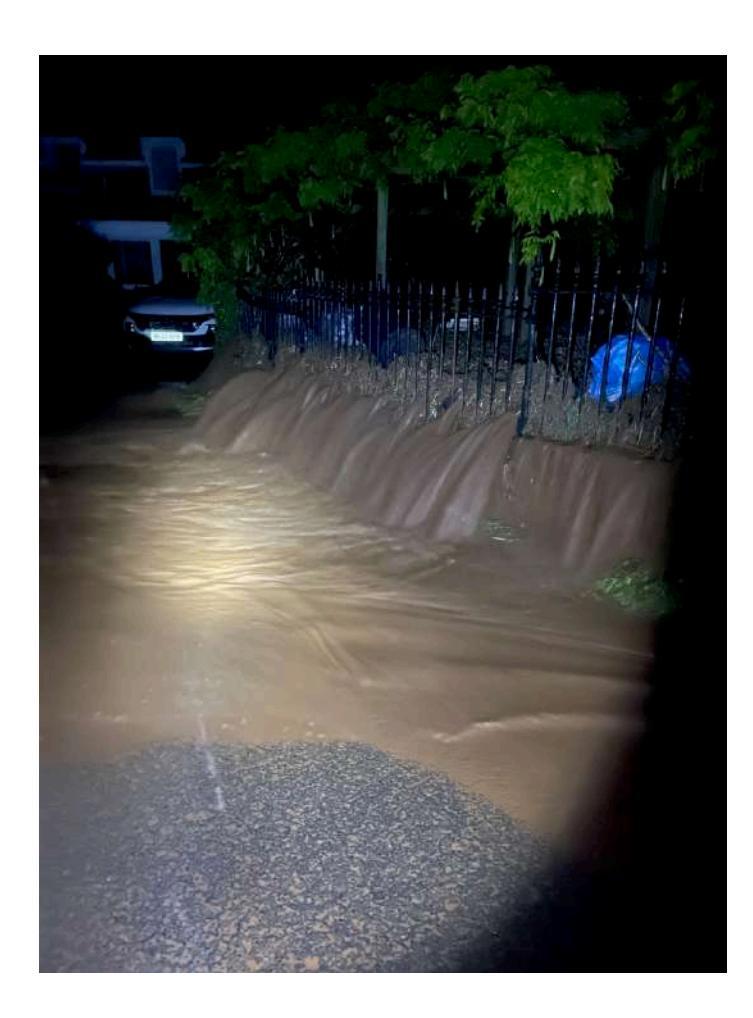
The flow flooded the front gardens of St Clement's

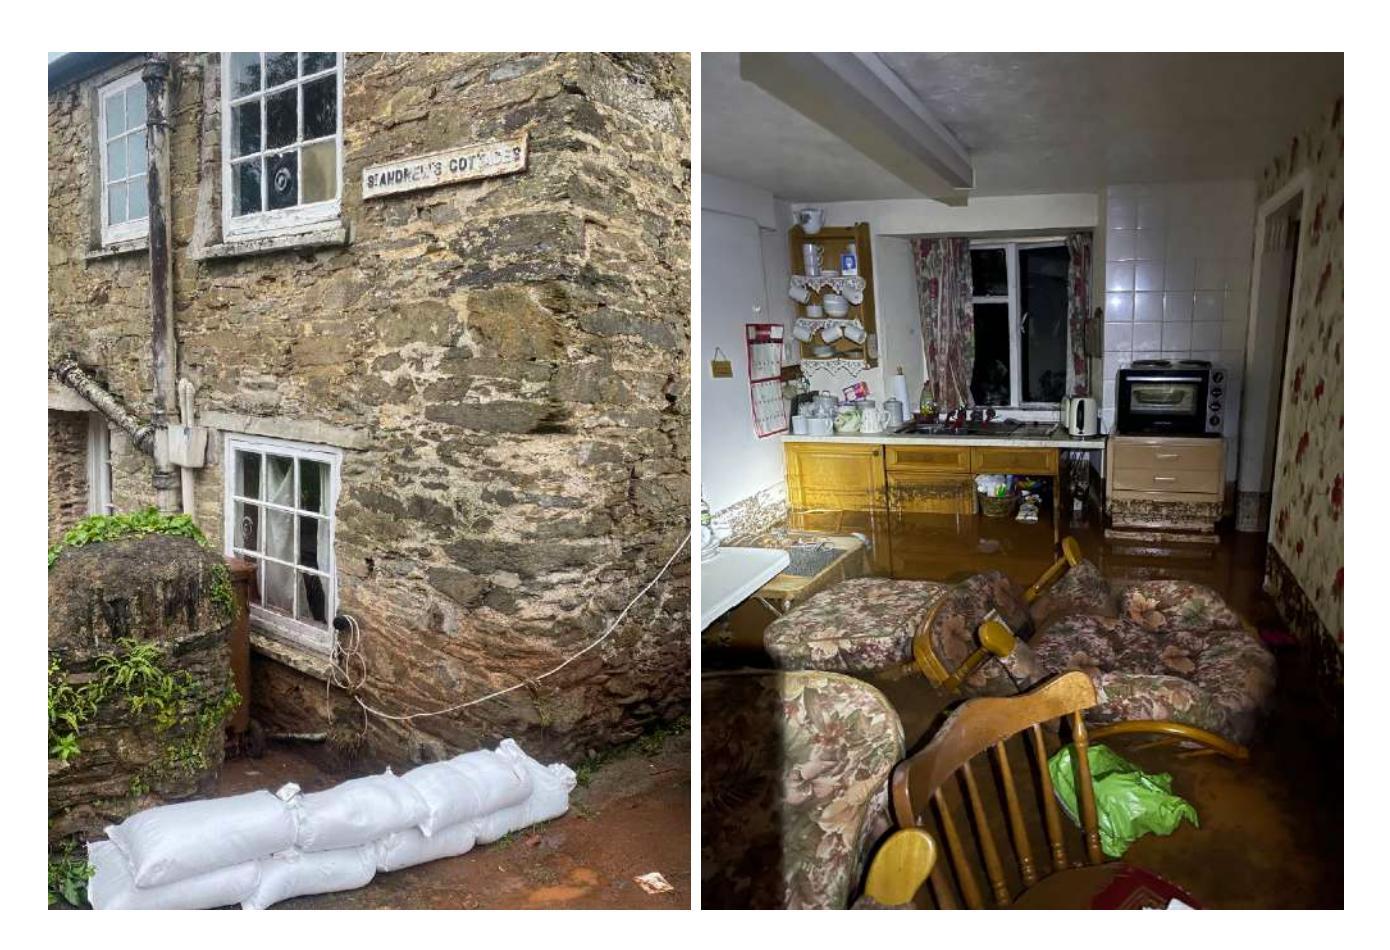
The high water mark on the doorframe brickwork is 4 bricks above the level on this photo taken at 03:09 which is 39 minutes after the peak rainfall measured on the rain gauges, so good correlation. 5.2.10 The flow passed around both sides of St Clement's Terrace, taking wheelie bins down Tristford Road. It carried on south, heading down Fore Street, crossing the road to flood St Andrew's cottages from the western gateway where the sandbags are in this photo.

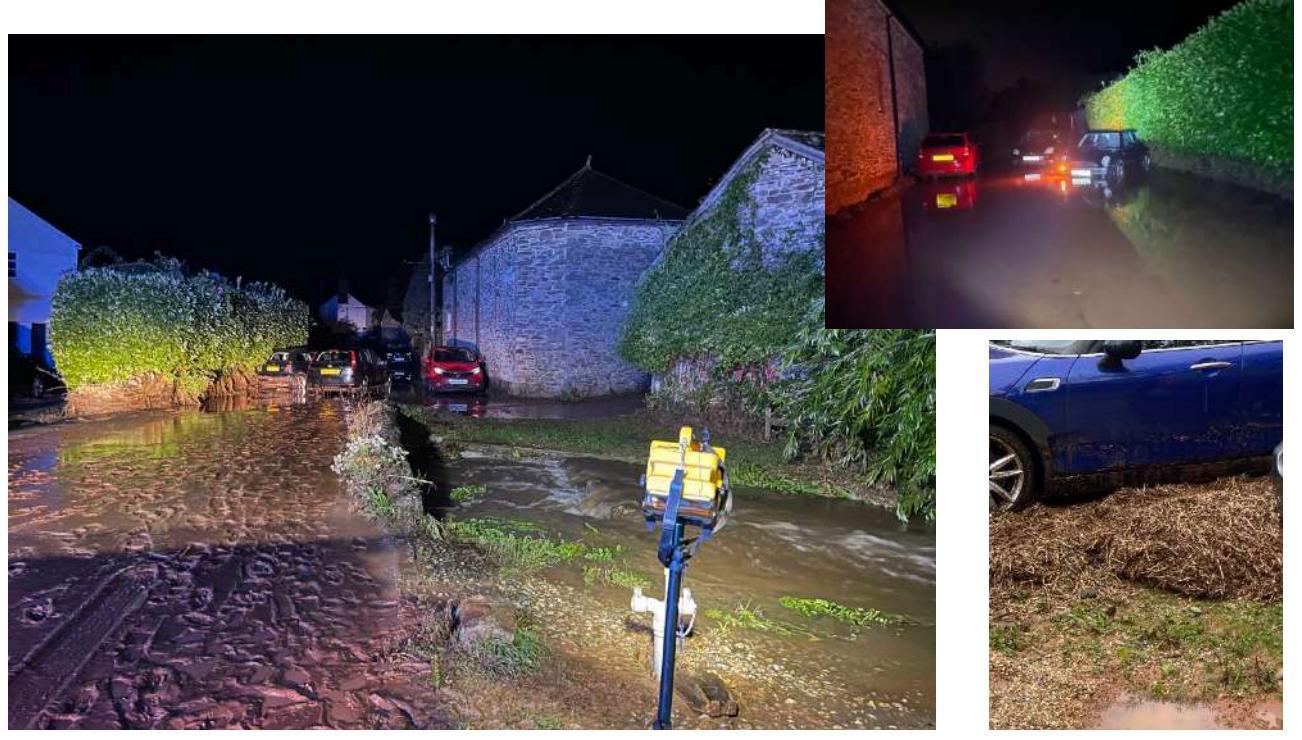
The flow was sufficient to lift and move cars.

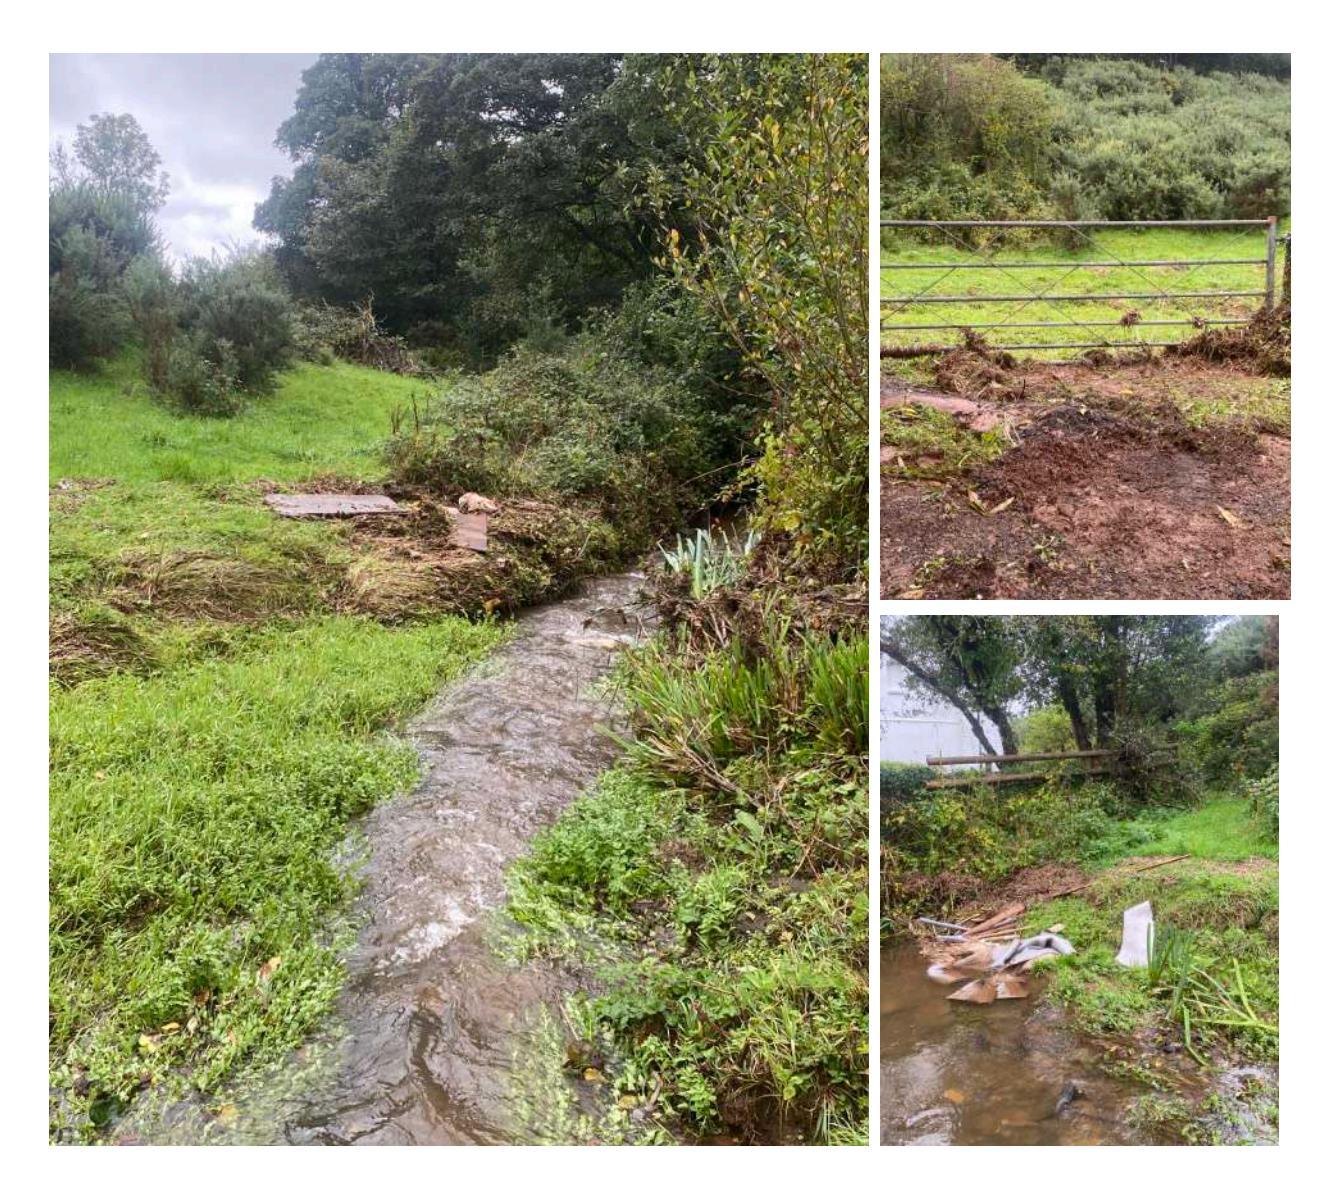
5.2.13 The final chokepoint was the narrowing of the stream heading down to the sewage works to the south of Vicarage Ball.

The waterline / scouring mark can be seen on the southern bank and gate rails.

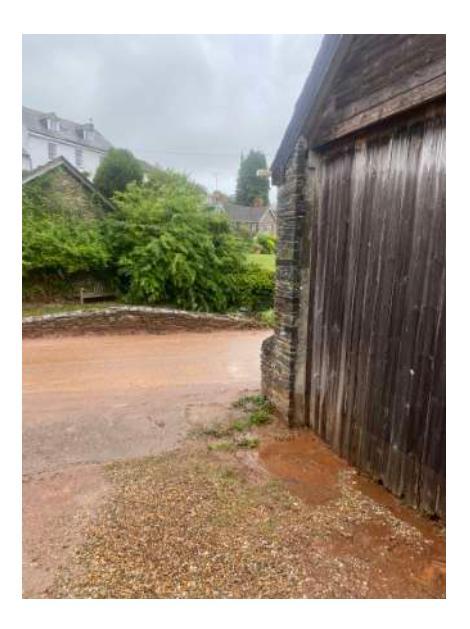
There was only a few traces of mud and straw in the garden of the Old Forge. Presumably this was caused by the stream's chokepoint above causing a

backing up against this garage door. The Old Forge did flood as it sits lower than this garage.

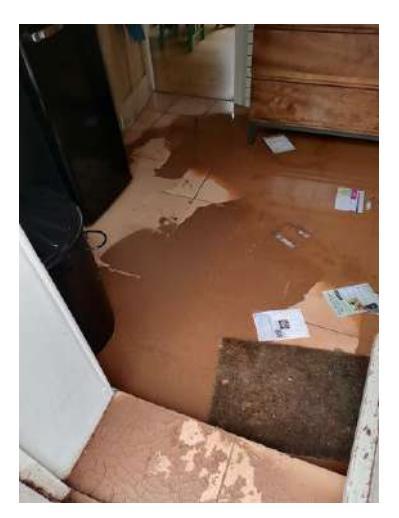
It was not all bad news. No 4 St Andrew's cottages had a well-fitting, sealed front door. It withstood the main flow with minimal ingress.

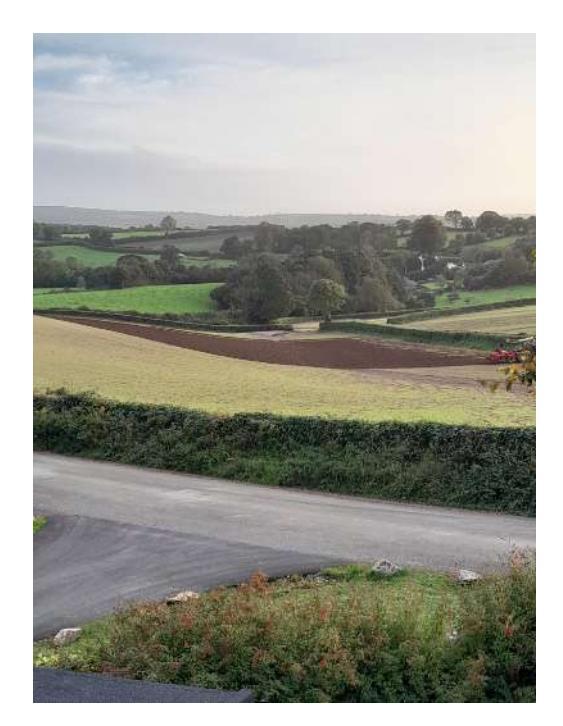
An example of a sub-soiler being used in one of the fields above Screw Lane several days after the event. The work is along the contour lines of Field 3.

The deep blades break and lift compacted sub-soil
