# **LMP-0094 - Soil Assessment of land where soil erosion and run off lead to flooding of Harberton Village on 17<sup>th</sup> September 2023**

## **Introduction**

This report presents the findings of a soil structure assessment undertaken on 20th September 2023 at land to the north of Harberton Village, near Totnes, Devon.

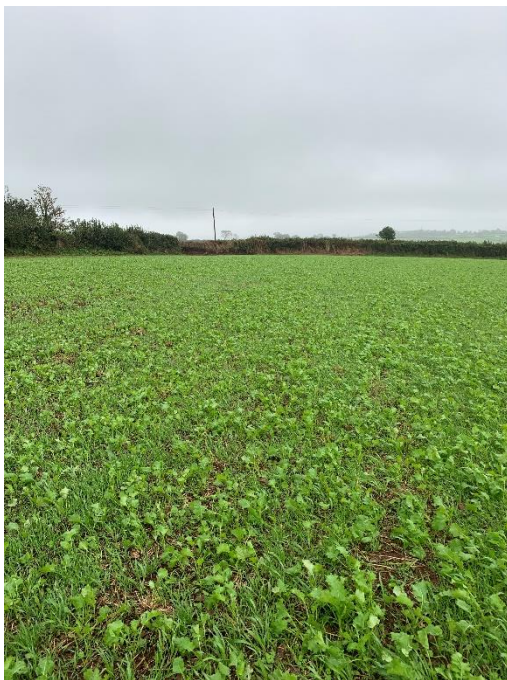
Fig. 2 – Forage crop surface

The soil surface in the forage crop showed signs of capping due to the heavy rainfall experienced. The soil surface in the grass reseed was capped and smeared probably due in part to the heavy rainfall but also due to the rolling that was undertaken when the grass was sown. Surface capping reduces the ability of the soil to absorb rainfall and effectively seal the surface thereby generating enhanced runoff and causing subsequent soil erosion. The forage crop on the day of survey had established across the fields, however the grass had not. Gullies and rills were evident across all parts of the slope leading down to the bottom of the fields.

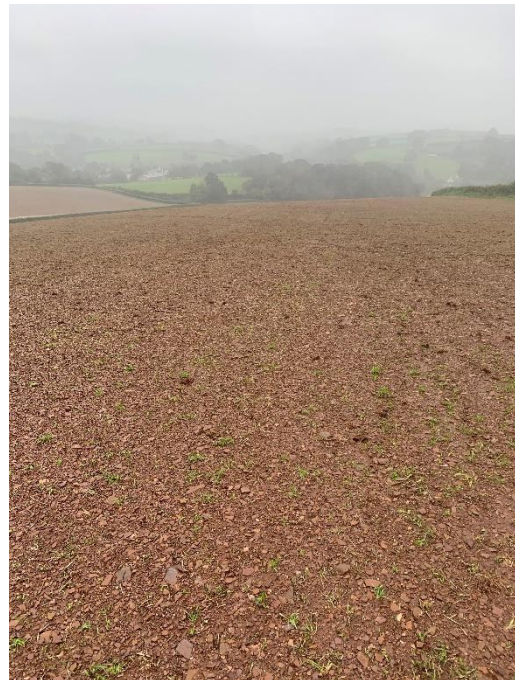
Fig 3. – Grass reseed surface

It is recommended that soil structure is assessed before cultivation and establishment of next crop in the rotation. This can be done by digging soil assessment pits over a representation of the fields in question to see at what depth the problems are, so that cultivations can be adjusted to need.

Cultivation to loosen the soil needs to be at a depth that will eliminate any compaction and allowing infiltration of the heavy rainfall that falls often in this exposed location.

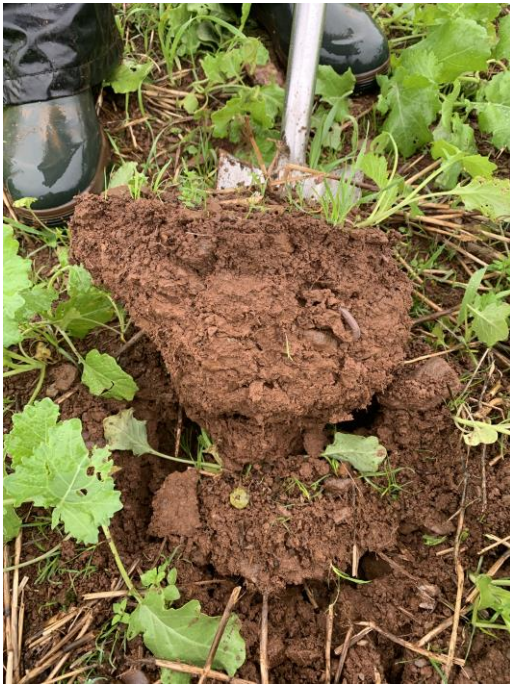
Fig.4 – Forage Crop Headlands

Figure 4 above shows that the topsoil on the forage crop headlands was compact below the first inch. This is different to the middle of the fields where the structure was good. Across the whole of the fields reseeded with grass, soil compaction was evident, below the top inch down to a depth of approximately 12-14 inches. Some earthworms were seen in the pits.

It was concluded that following heavy rainfall, some overland flow occurred on the headlands on the forage crop fields at the top of the slope. This overland flow entered the newly sown grass fields causing surface water runoff to occur, taking a significant amount of topsoil with it. All newly sown grass fields showed signs of erosion with the fields themselves adding to the amount of runoff seen. There were many gullies and rills evident.

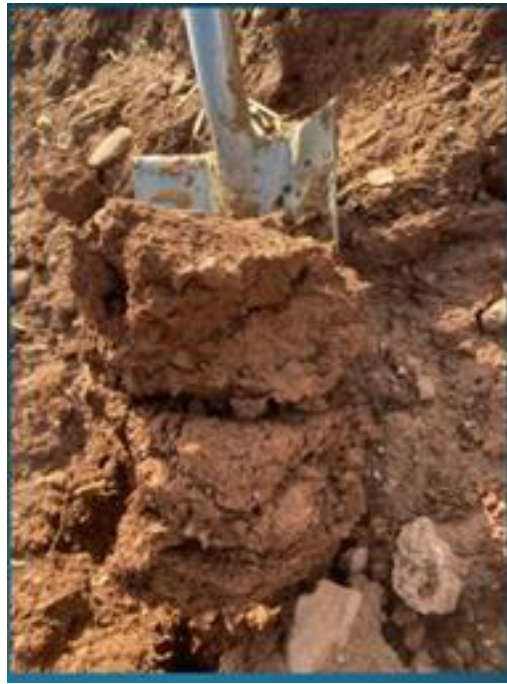
Fig 5. – Grass reseed

It is believed that the level of compaction in the fields seen was caused by the minimum tillage operations as deep level soil compaction was not identified and action was not taken to alleviate it.
