Harberton Flood

17th September 2023

1 Purpose and scope

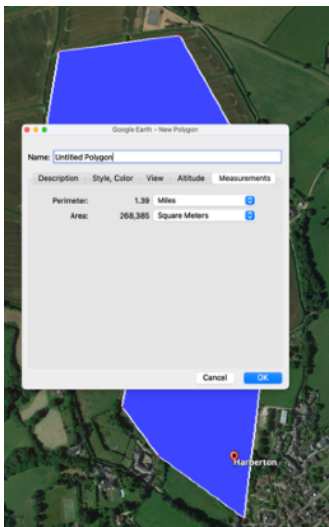
The water heading into Harberton from the north east can be assumed to have fallen on this blue polygon plan area of 268,000 m²

Therefore the volume of water in this period was;

10,000 m³ (268,000 X 0.038)

4,500 m³ (268,000 X 0.017)

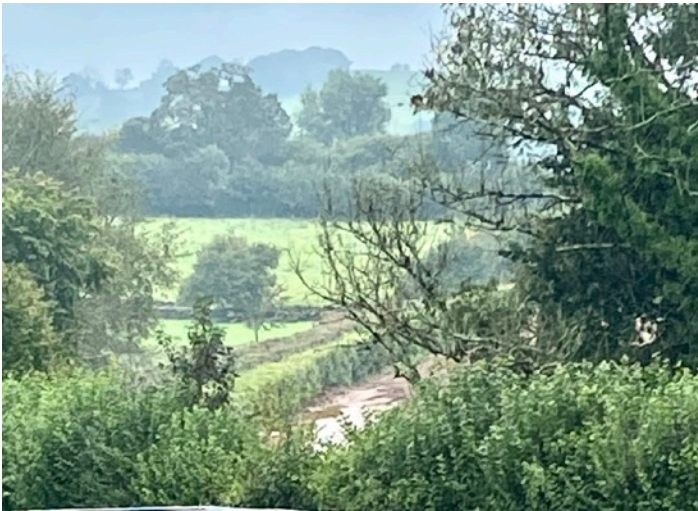
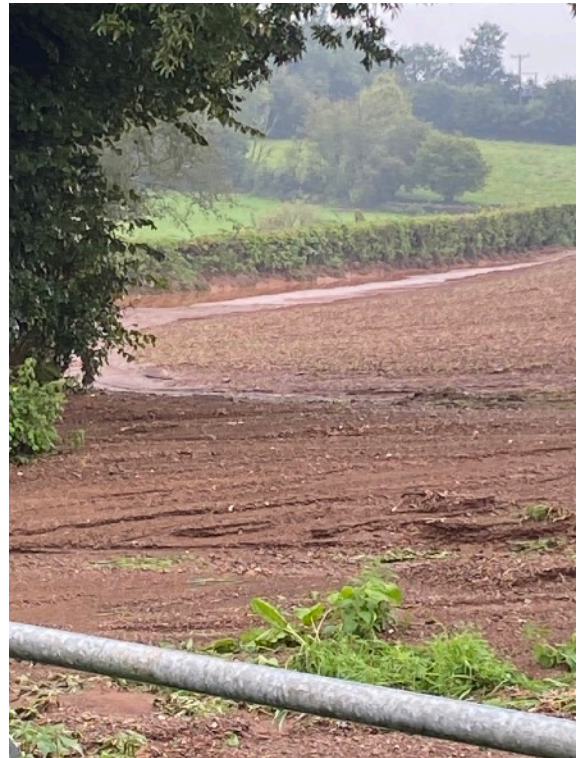
Water banked up and pooled along the fields' southern banking forming the north side of Screw Lane.

Established crop north of fields 1,2,3 and 4, looking down on the freshly-tilled and seeded fields in the far distance.

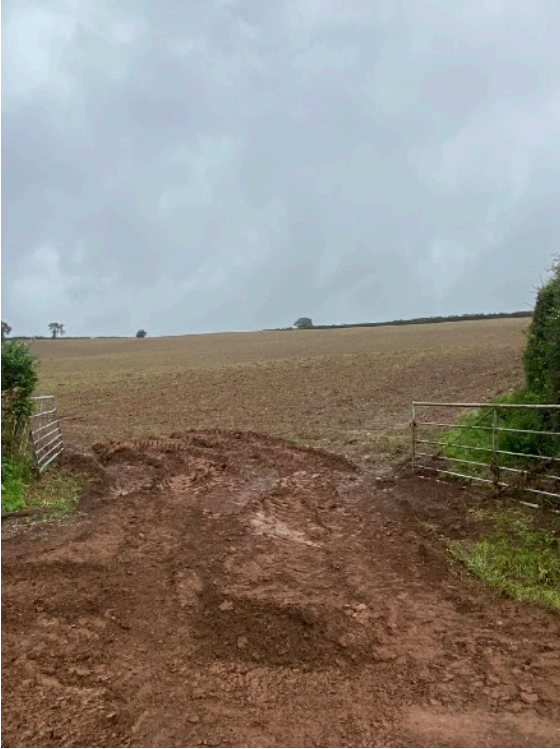
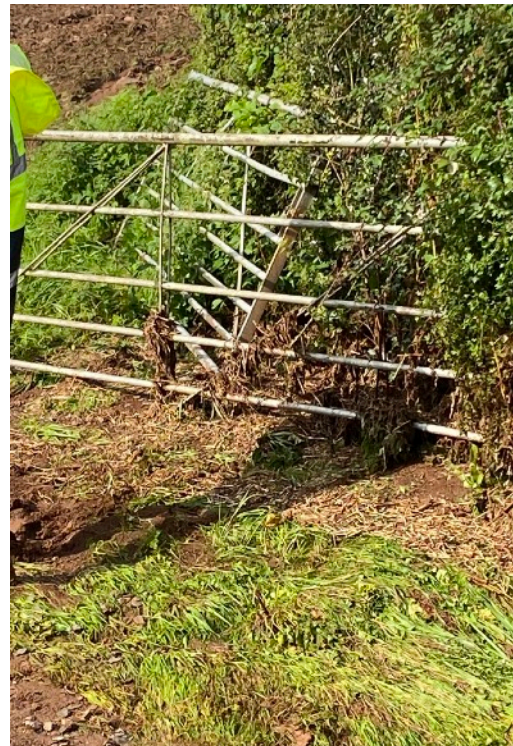
5.2.2 The flow went through the two field gateways and hedge apertures onto Screw Lane. The run-off was held between the high banks on either side as the buddle holes blocked with straw and mud. The evidence on this gate indicated there was minimal build-up behind the gate. Its open structure allowed relatively free flow to scour the gateways clear with minimal straw retention up to three bars high on the gate.

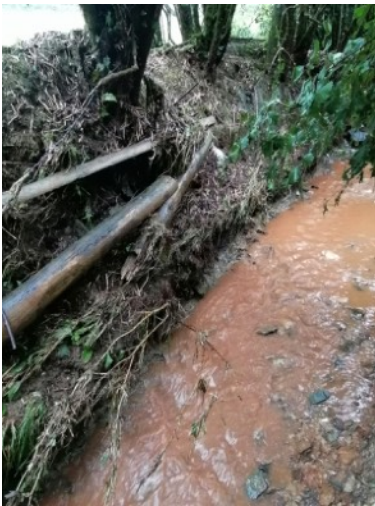
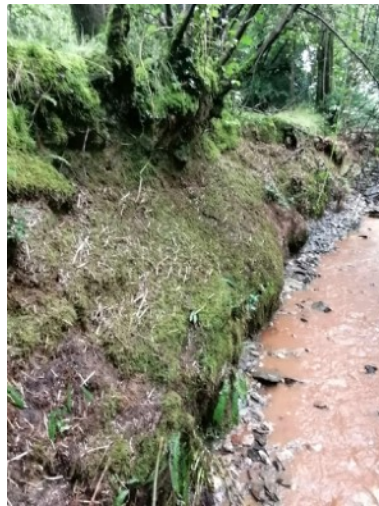
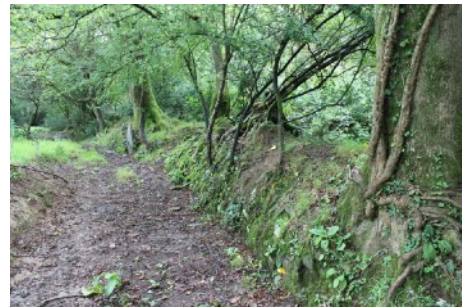
... then onwards south east down to the village. It is joined by a much smaller stream from the cricket pitch road. There are freshly broken fences, but no evidence of any significant dams along the stream.

Levee

The stream has 1.5m levees on it's west bank to protect the field to the south. However there are gaps in the levee which caused spillage

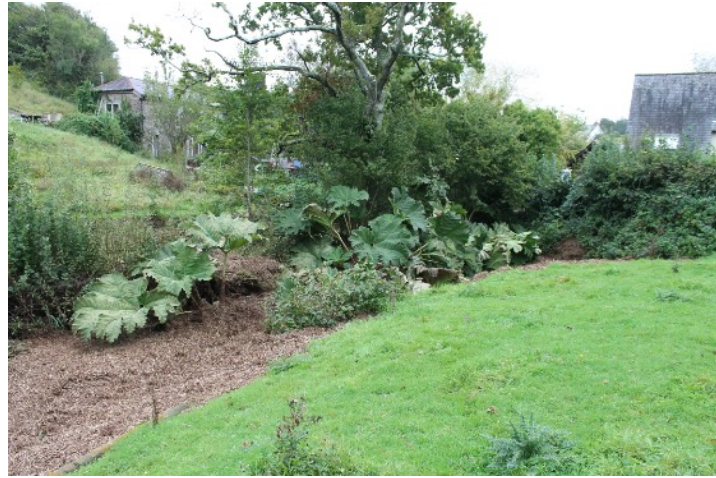
The levee spillage eastwards was significant. It backed up against the Gunnera plants behind Ashbrook Cottage

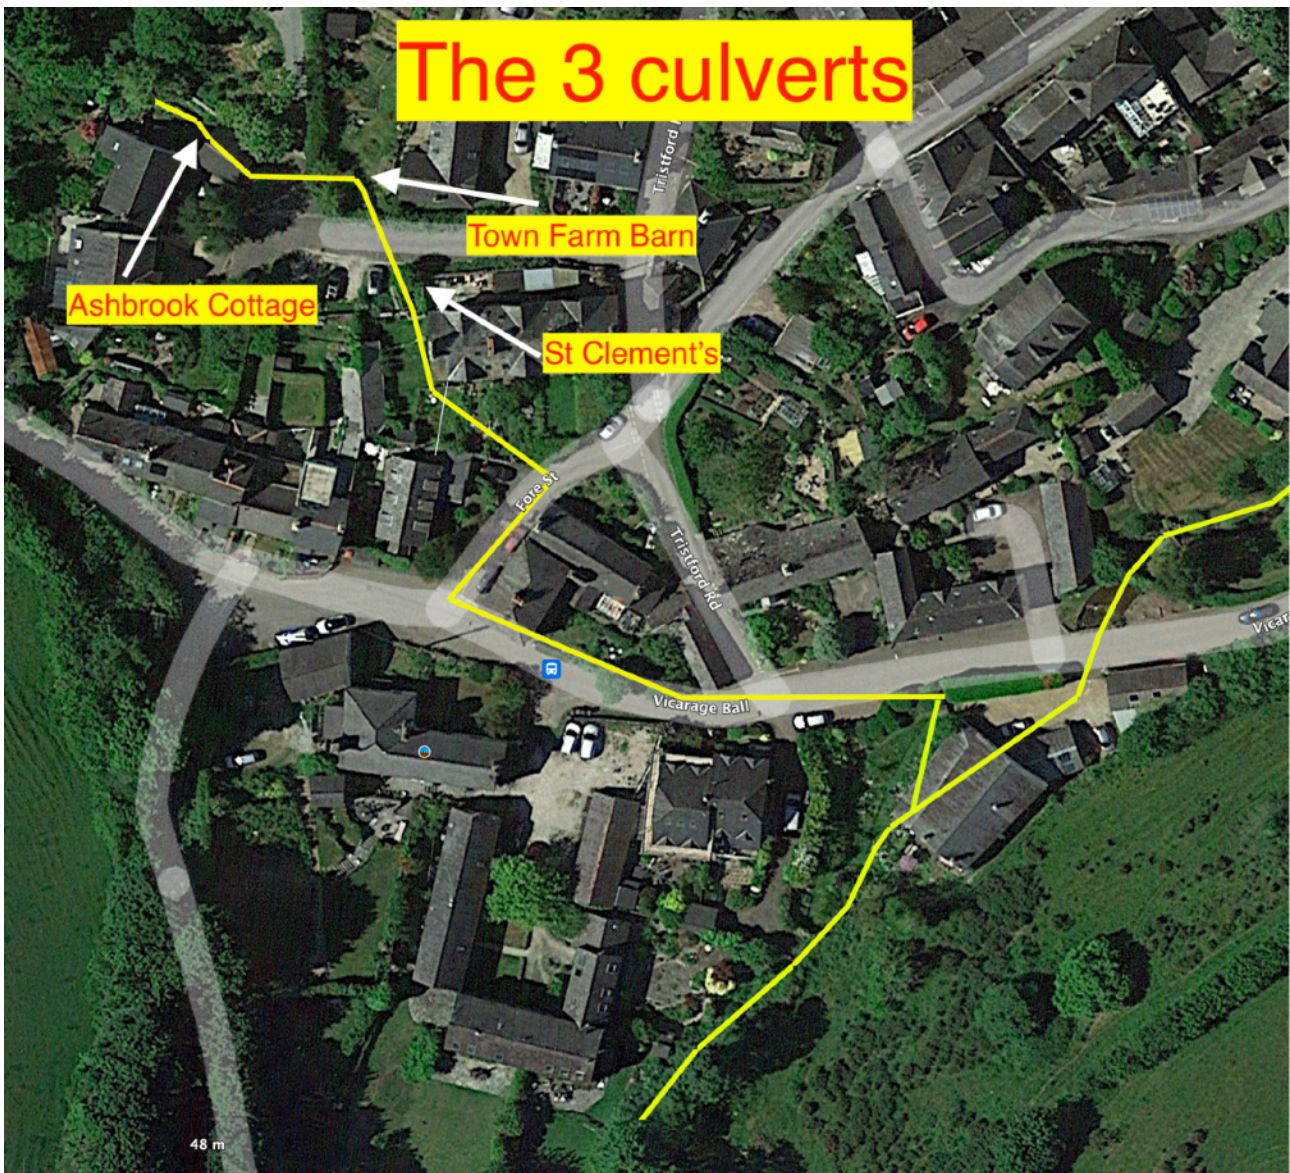
In particular, can St Clement's 0.27 m² culvert pass 4,500 m³ in 15 minutes?

The Fire Service cleared the culverts at 04:30. Unfortunately the degree of blocking was not recorded or witnessed in any detail at time of writing.

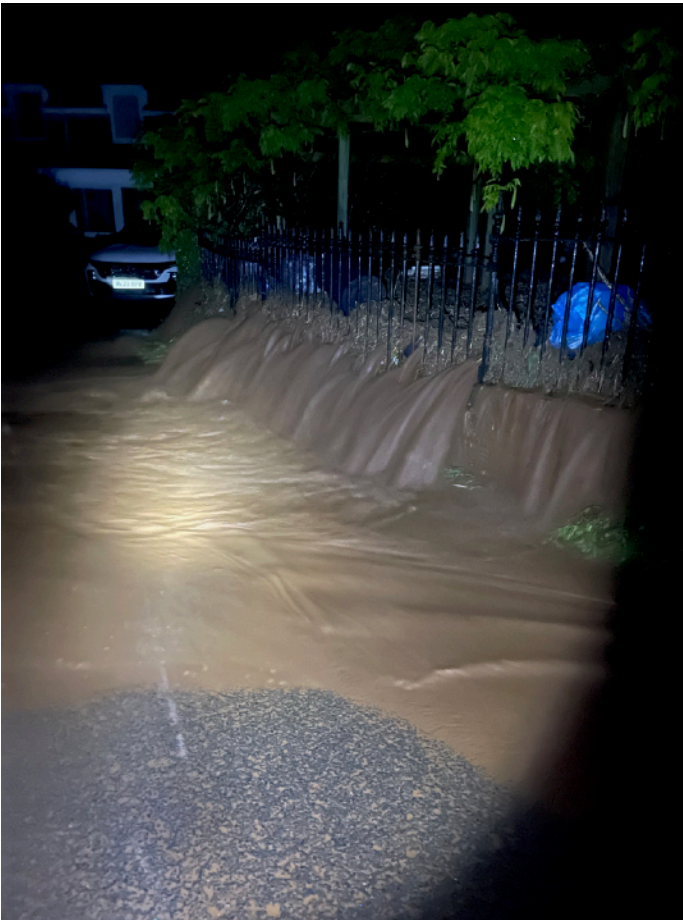
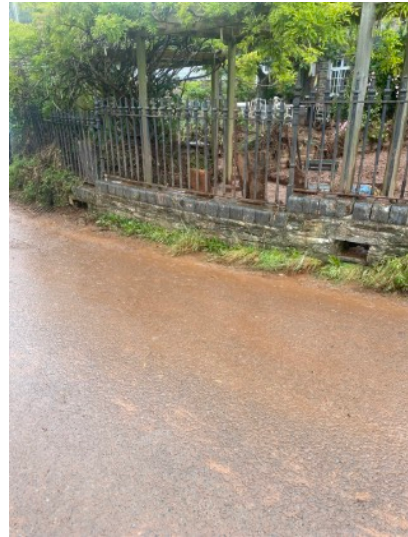
The flow flooded the front gardens of St Clement's

The high water mark on the doorframe brickwork is 4 bricks above the level on this photo taken at 03:09 which is 39 minutes after the peak rainfall measured on the rain gauges, so good correlation.
