## Ordinary Meeting of Harberton Parish Council Tuesday 14<sup>th</sup> November 2023

## Item 10: Flooding in Harberton Parish

## **Harberton Flood**

# 17th September 2023

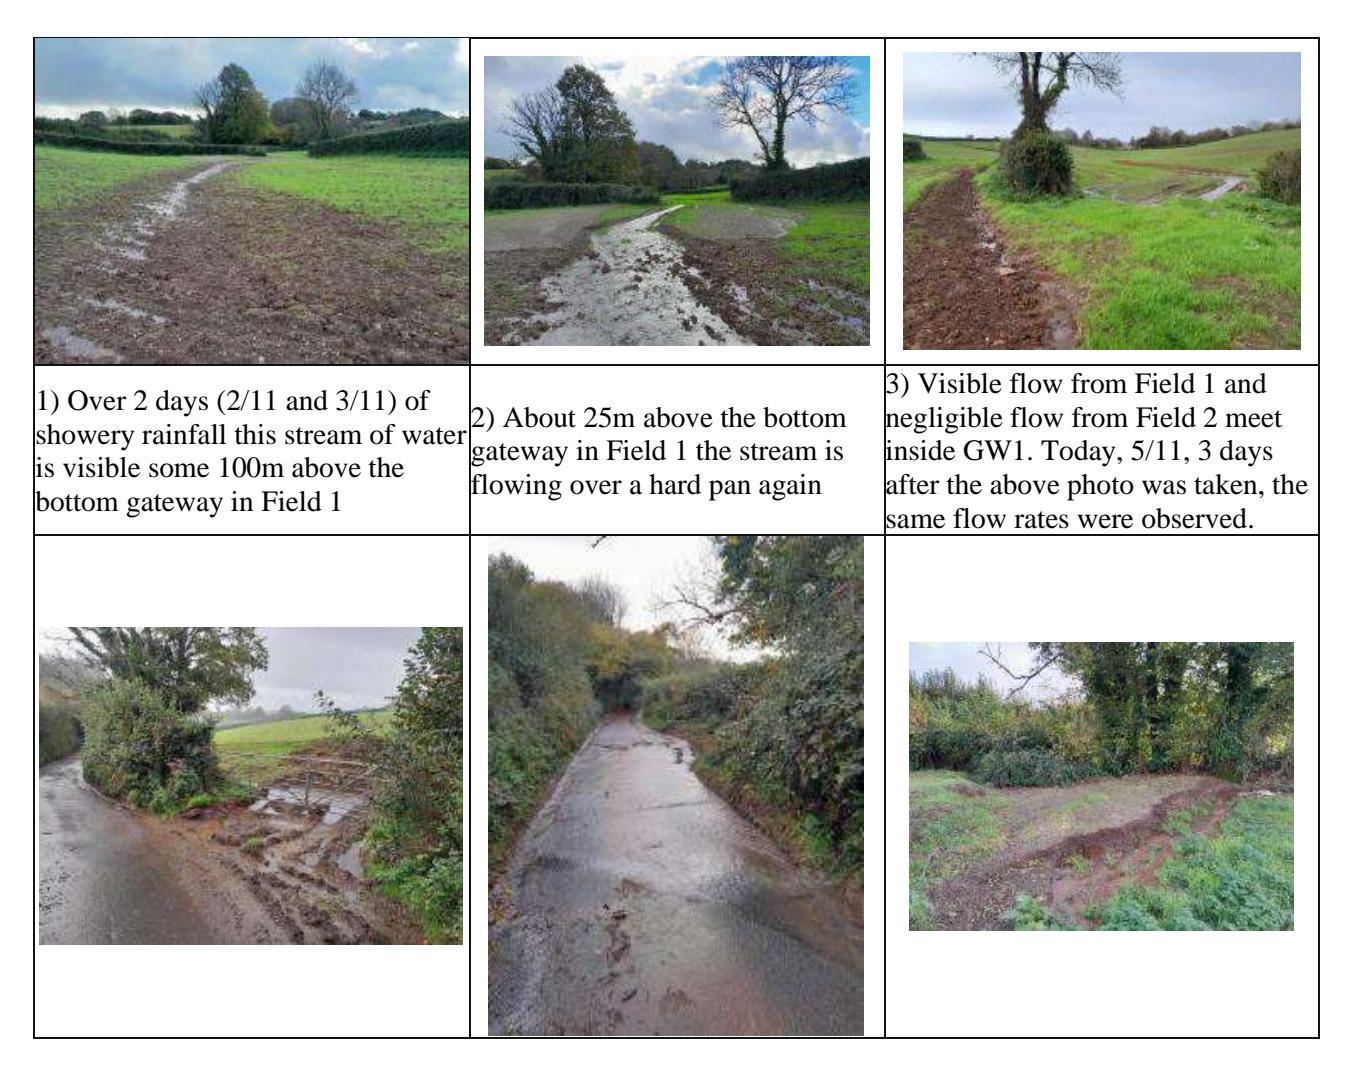
4) Road clearance initially by farmer and later by DCC a few days after the 17/9 flood was mostly dumped inside GW1	5) Blockage of a pipe under the road is still causing a lot of runoff from Fields 1 & 2 to appear on the right in this photo and flow down the road	<ul><li>6) The rest of the runoff from Fields</li><li>1 &amp; 2 is now diverted westwards by</li><li>the initial flood deposits</li></ul>

7)to flow along behind the hedge bank in Field 4 where a	8)huge deposit of soil has built up. The next image is taken through the hedge gap approx. 1/3 in from the left edge of the photo	9) This is almost opposite where the open ditch passes through a buddle hole into Tristford Farm Orchard

10) A few metres further to the W, where the silting ends, the water flow pools and runs through the hedge bank (see photo 12)	11) Meanwhile, at the same time, there is no runoff flow through GW2 from Field 3	12) Water flowing through hedge bank on left from Field 4 into Screw Lane

13) A combination of water seeping through the hedge bank from the saturated silt behind, water running down the road from the blocked pipe, and the road water getting constantly splashed against the bank	14) has caused a significant collapse of bank soil into the road over a length of some 10 metres. With a huge weight of saturated soil behind the hedge bank	15)there is a <b>possibility of</b> <b>complete collapse of the hedge</b> <b>bank</b> , which would block the HGV route around Harberton and cause great inconvenience

The pipe under the road and the open ditch must be properly cleared and sufficient dumped material inside gateway GW1 must be re-located to allow the normal runoff (mainly from Field 1, with a little also from Field 2), along with the normal land drainage from the 'spring', to reach the pipe under the road instead of flowing down the road and westwards along behind the hedge bank in Field 4.

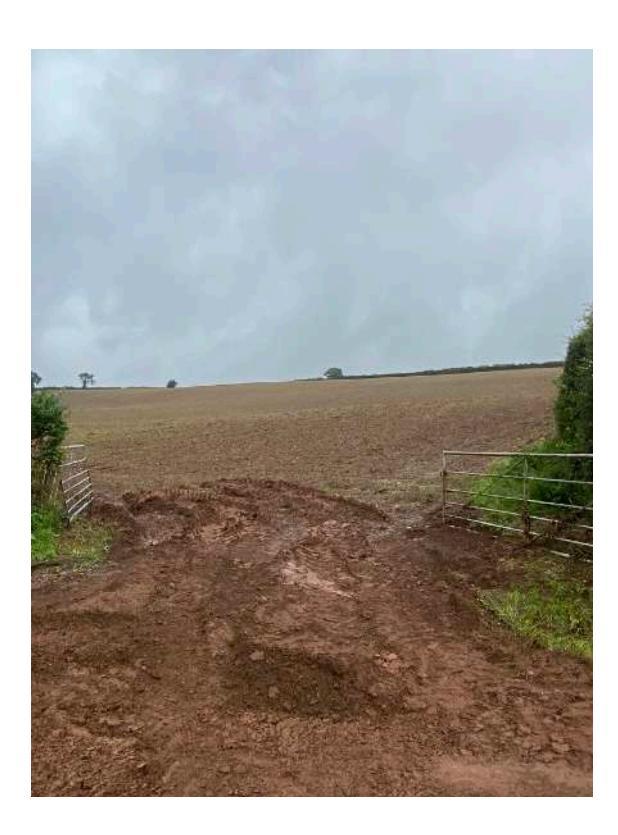
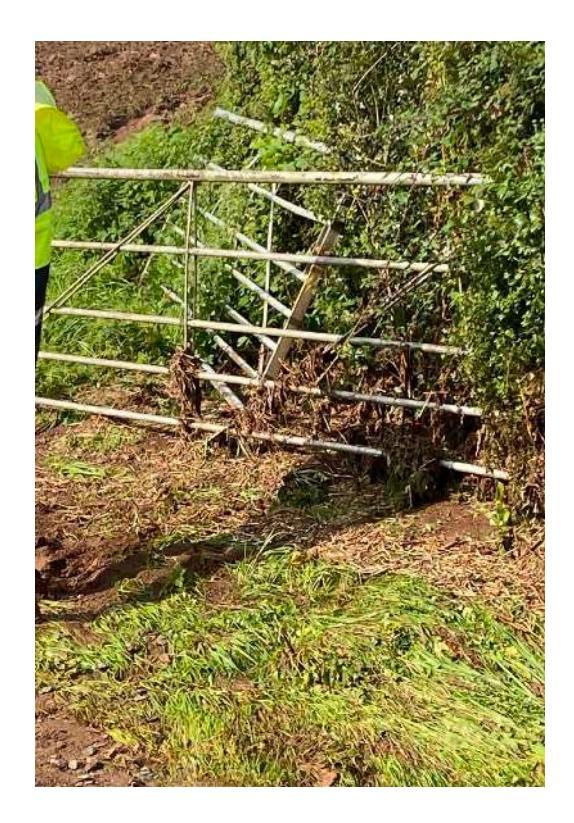
5.2.2 The flow went through the two field gateways and hedge apertures onto Screw Lane. The run-off was held between the high banks on either side as the buddle holes blocked with straw and mud. The evidence on this gate indicated there was minimal build-up behind the gate. Its open structure allowed relatively free flow to scour the gateways clear with minimal straw retention up to three bars high on the gate.

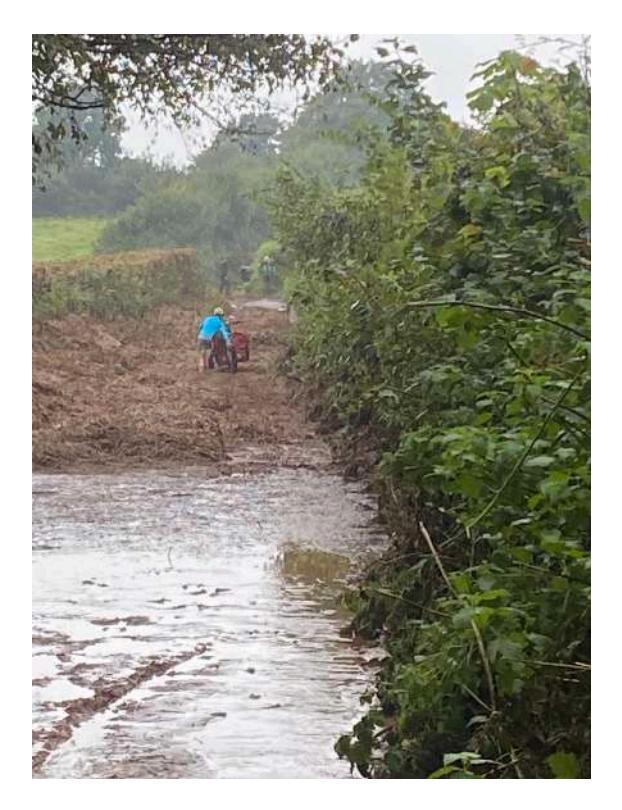
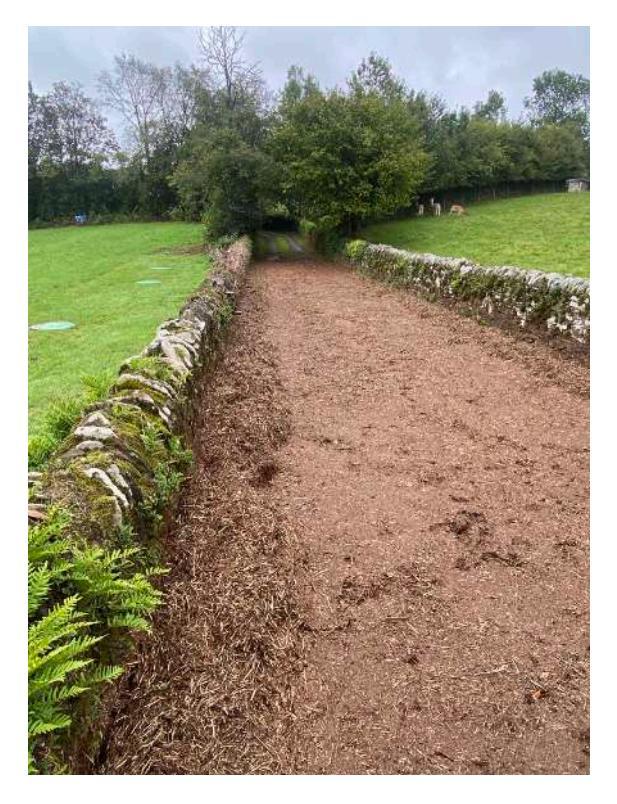
5.2.3 Screw Lane has a slight hump to the east of Field 1's gate. This caused the flow from this filed to head west which spilled round and pooled in Threshing Barn's driveway.

Threshing Barn's driveway walls held. As Screw Lane filled up, the hump was submerged, and the gateway and buddle holes on the south side of Screw Lane overflowed. Screw Lane became a huge attenuation pool.

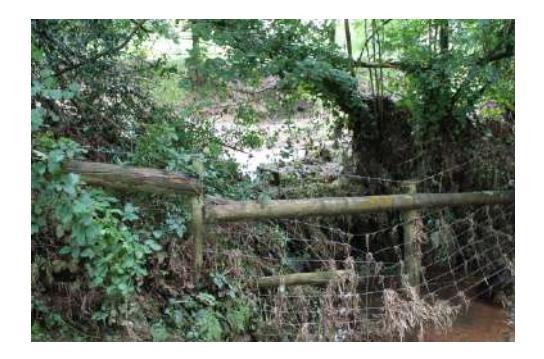
5.2.6 The pond overflowed into this subordinate pool,

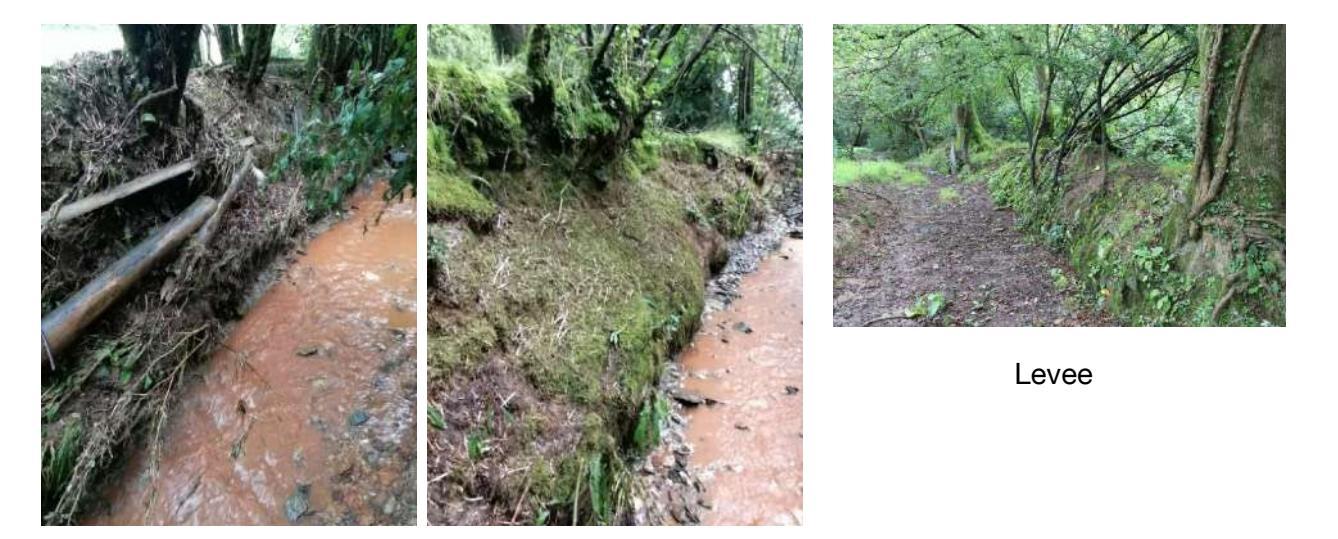
... then onwards south east down to the village. It is joined by a much smaller stream from the cricket pitch road. There are freshly broken fences, but no evidence of any significant dams along the stream.

The stream has 1.5m levees on it's west bank to protect the field to the south. However there are gaps in the levee which caused spillage

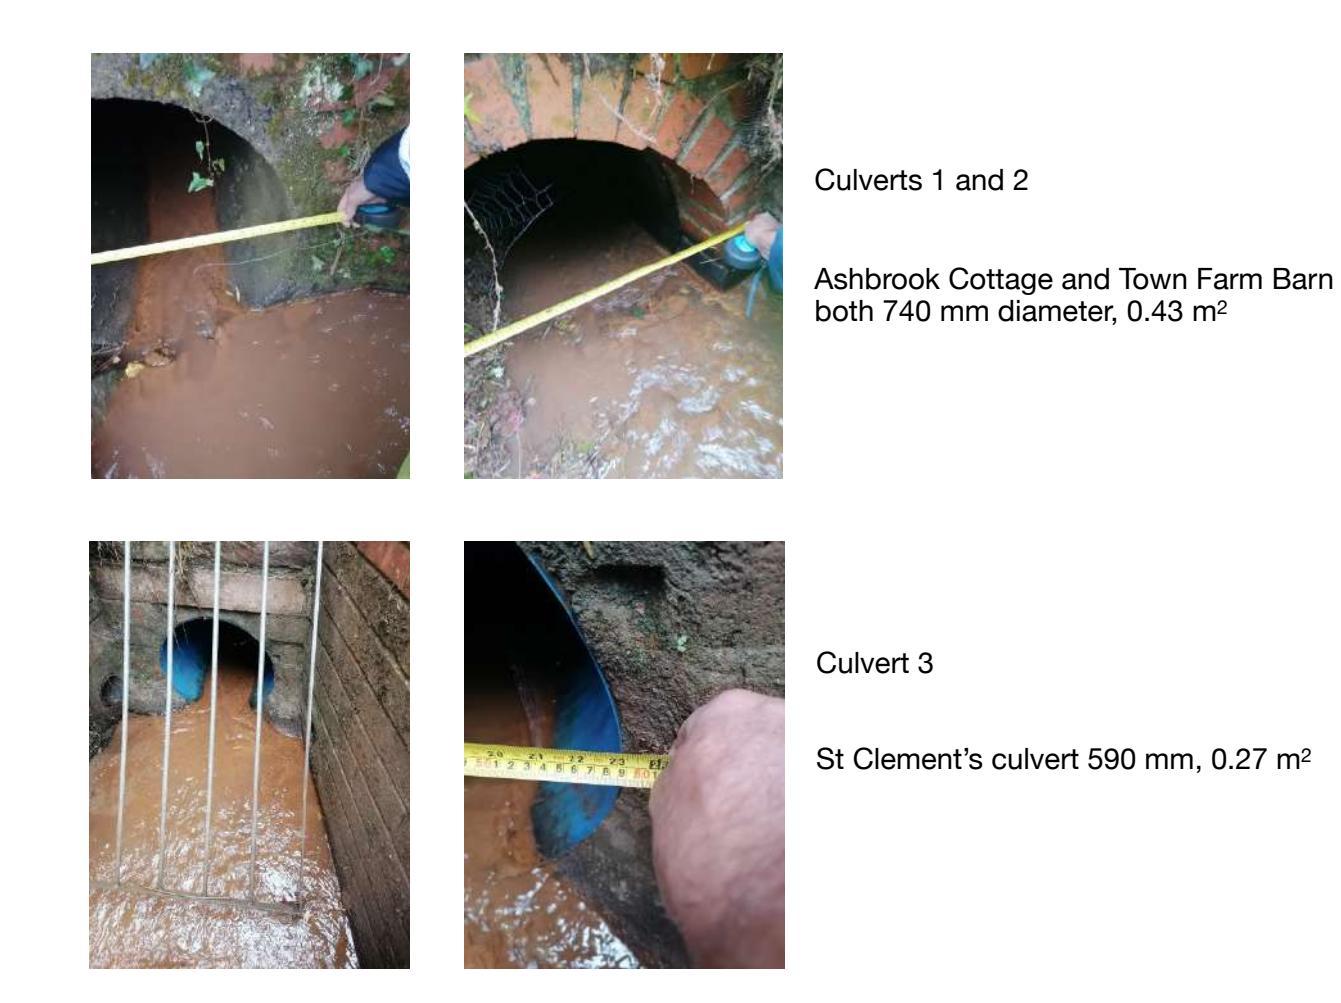
The first culvert heads west under Ashbrook Cottage's garage. This culvert was overwhelmed. The flow went around both sides of the garage, taking the side gate off it's hinges.

The flow through the Ashbrook culvert then went west for a few metres to Town Farm Barn. It dog-legs at Town Farm Barn's rear culvert. Town Farm Barn flooded from front and rear as the flow went approx 220 degrees around the house.

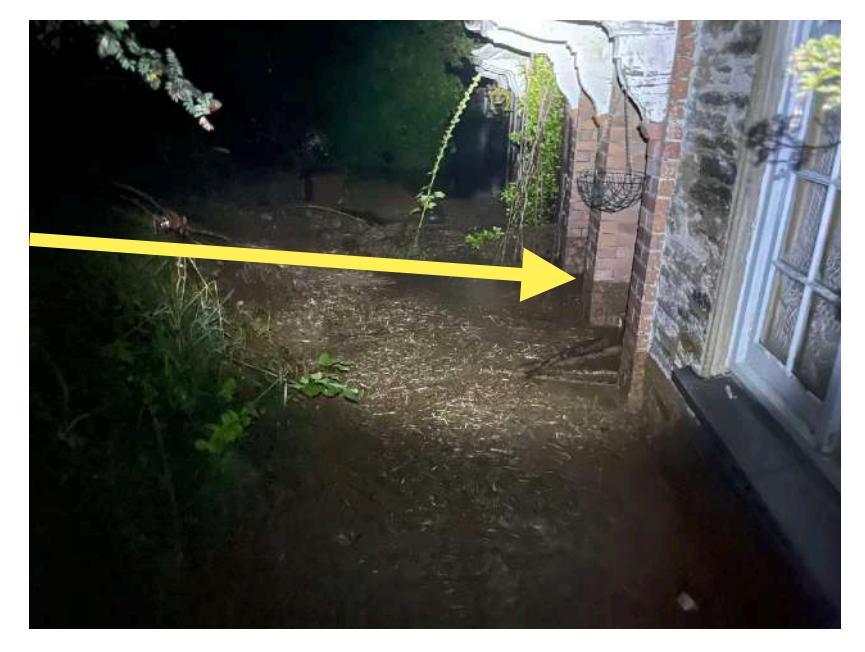
The high water mark on the doorframe brickwork is 4 bricks above the level on this photo taken at 03:09 which is 39 minutes after the peak rainfall measured on the rain gauges, so good correlation. 5.2.10 The flow passed around both sides of St Clement's Terrace, taking wheelie bins down Tristford Road. It carried on south, heading down Fore Street, crossing the road to flood St Andrew's cottages from the western gateway where the sandbags are in this photo.

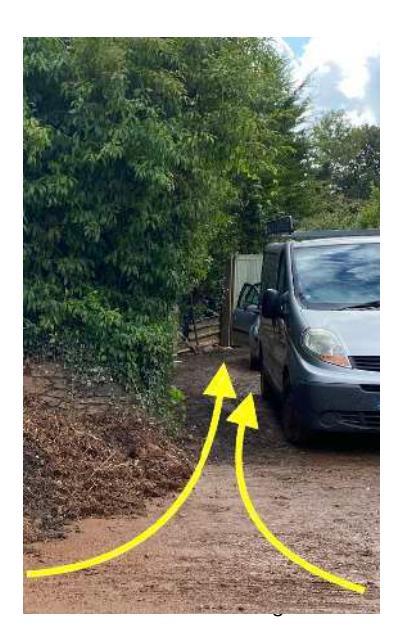
His house was spared, those either side were not.

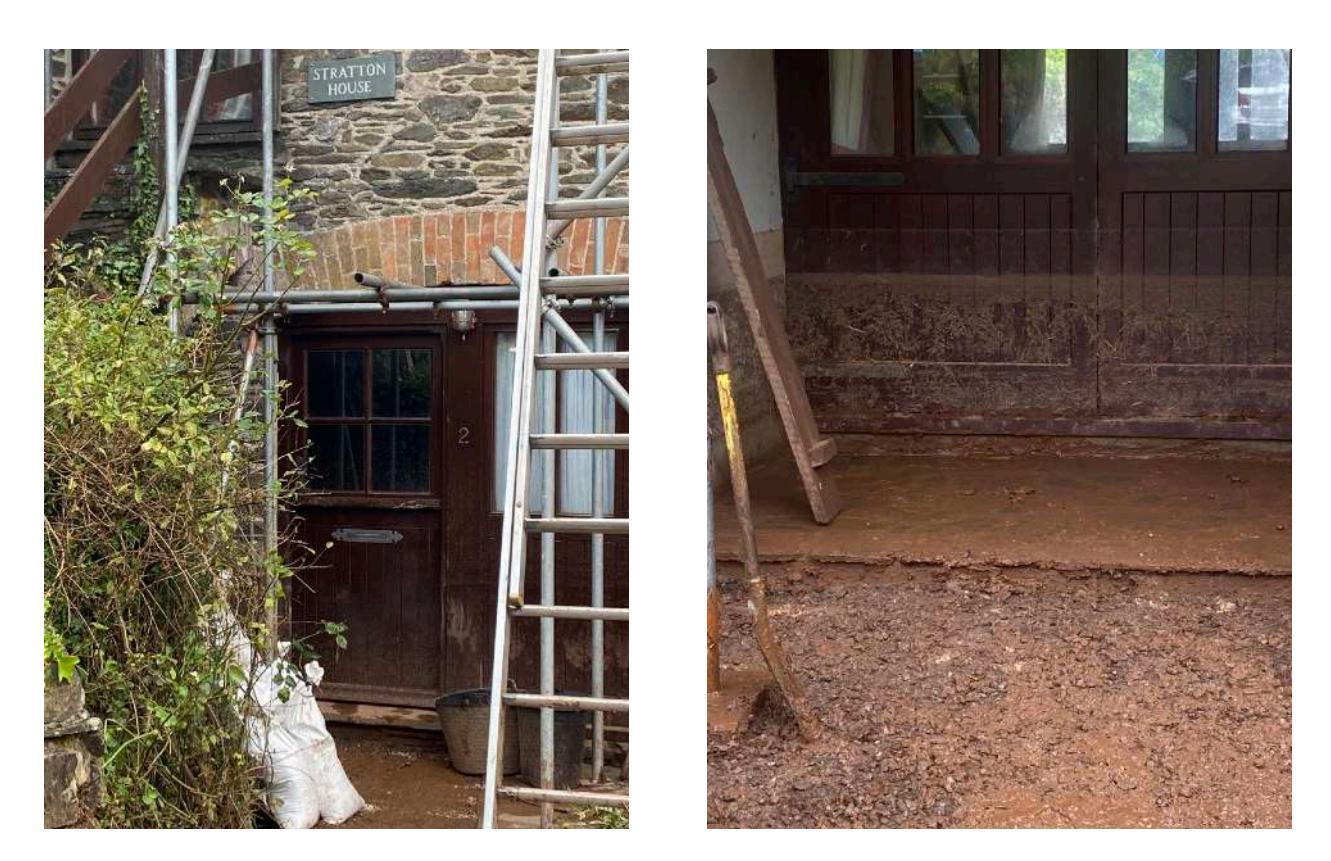
5.2.12 Preston barns 'U' shaped courtyard had the lowest affected properties and now perhaps the more challenging mitigation for future floods as the original archway has been in-filled.

Note the flow did not reach the second stream entering the village from the east. This is a completely different system from a different valley. The stream was full, but contained within its banks. The mud on the road here came from the west, not the stream from the east.

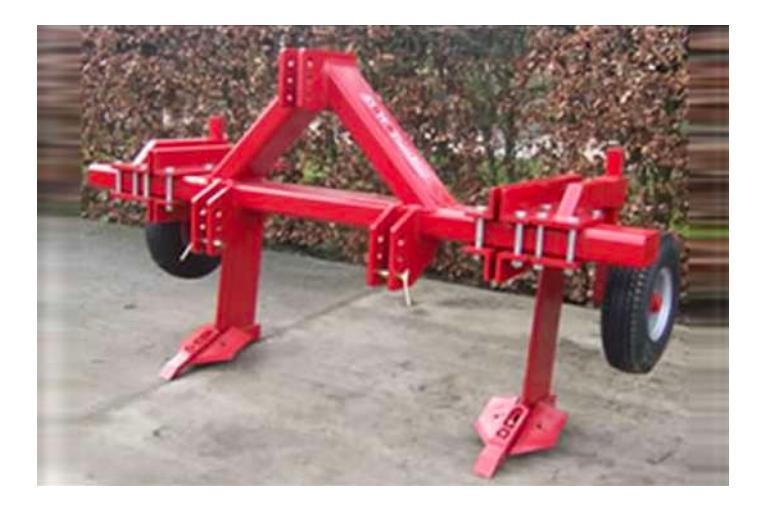
An example of a sub-soiler being used in one of the fields above Screw Lane several days after the event. The work is along the contour lines of Field 3.
